Conservation Methodology Report

Cashel City Walls 2014 Defects at Section A (Roselawn Close), Cashel, Co. Tipperary.

**Client:
Cashel Town Council,
Town Hall,
Friar Street,
Cashel,
Co. Tipperary.**

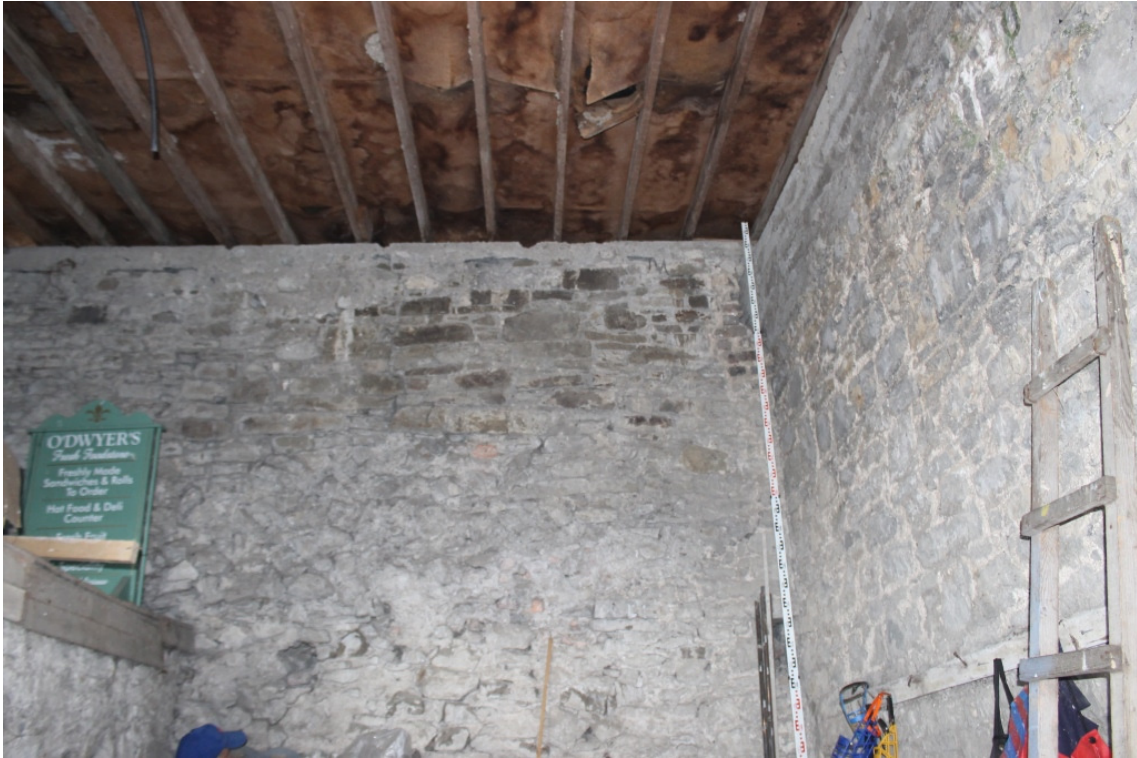
Area 1 – Internal Face – Taken 24/10/14

The internal face of Area 1 is in a reasonably good condition. Any cementitious material should be carefully removed by hand from the wall, unless otherwise agreed by the supervising consultant, and the wall re-pointed with a lime based mortar, specification of which to be provided by Tipperary County Council based on their previous repair projects on the wall.

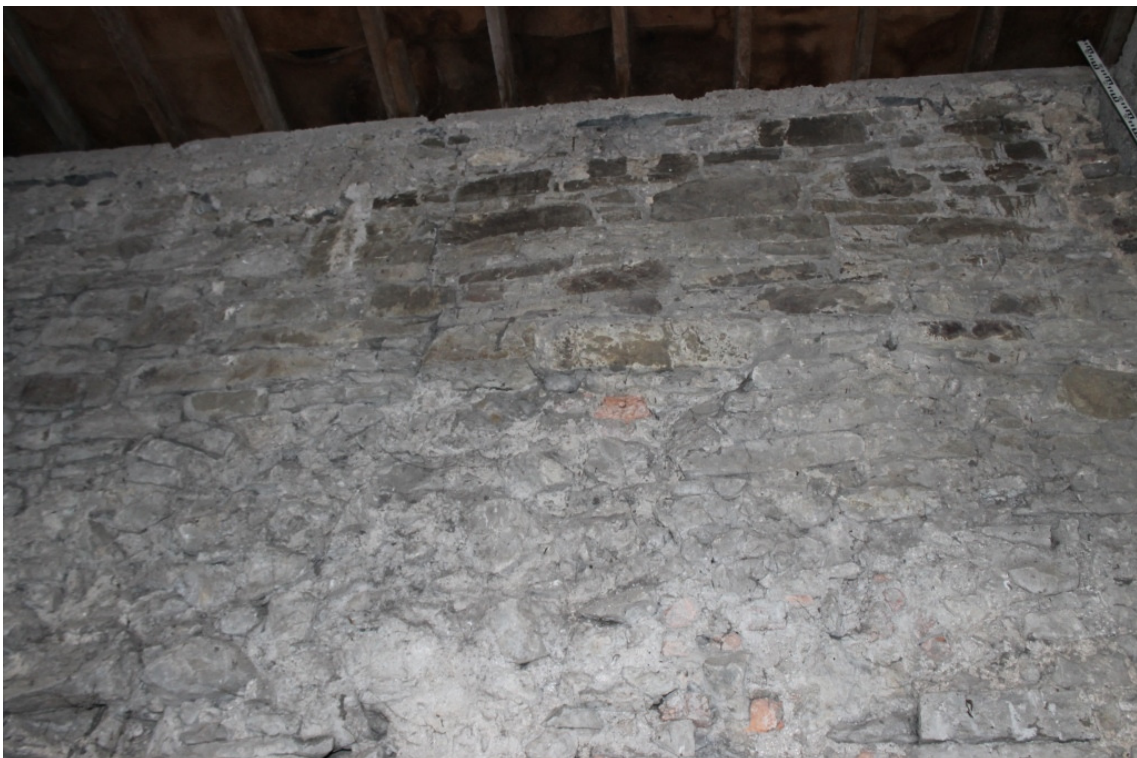
The wall as measured in the southern most internal storage shed is 4.65 metres high. The timber roof joists span onto the city wall. The wall is constructed with rubble masonry. There appears to be a change in the size of stone used at approximately 3.5 metres high in this section. There are open joints and voids apparent in the internal section of this wall. There is vertical cracking at the junction of the rear wall and the internal, single-storey division wall also.

Area 1 – Internal face – Change of Stone – Taken 24/10/14

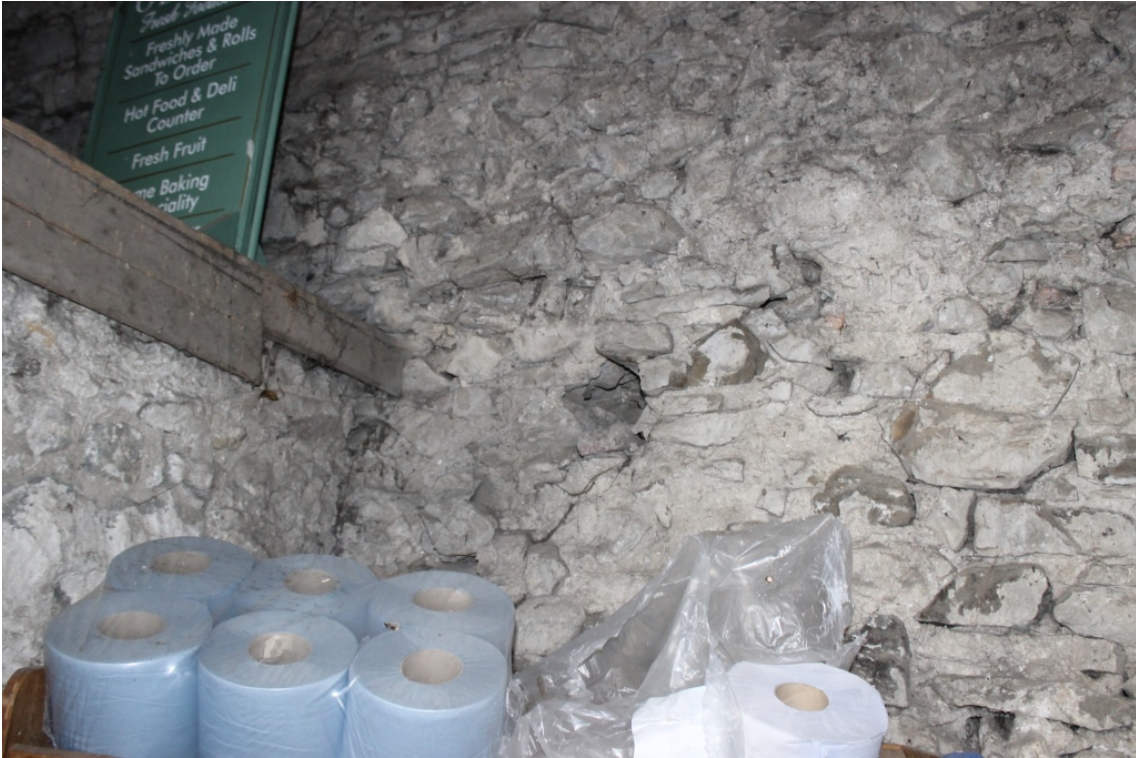
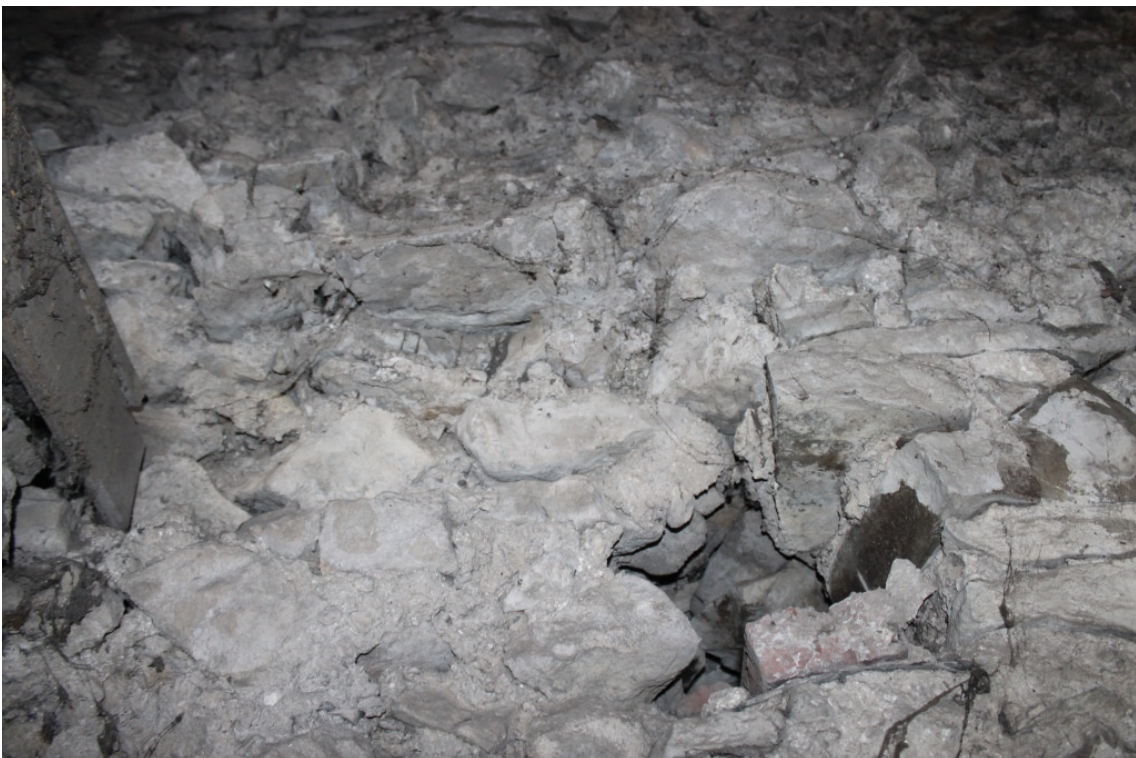
Area 1 – Internal Face – Open Joints and Void in Wall - Taken 24/10/14

Voiding in this section of wall does not appear to be extensive however, prior to remedial works being undertaken, it would be prudent to remove a number of stones in locations to be confirmed to identify if grouting would be required.

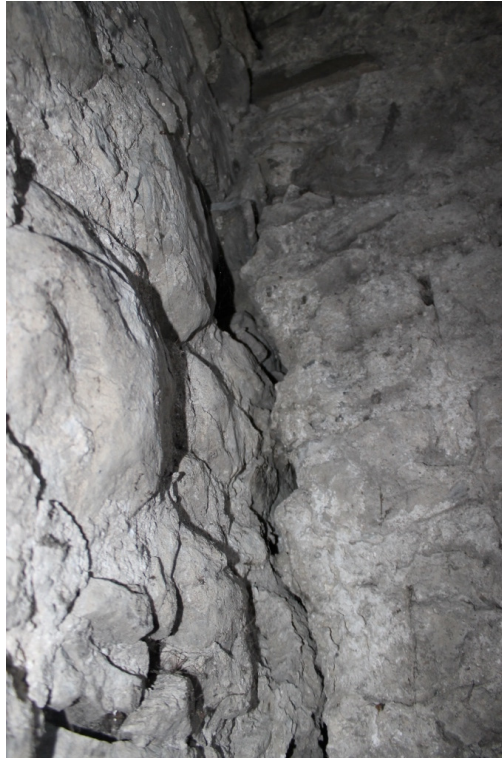
Area 1 – Internal Face – Cracking at Junction with Internal Division Wall - Taken 24/10/14

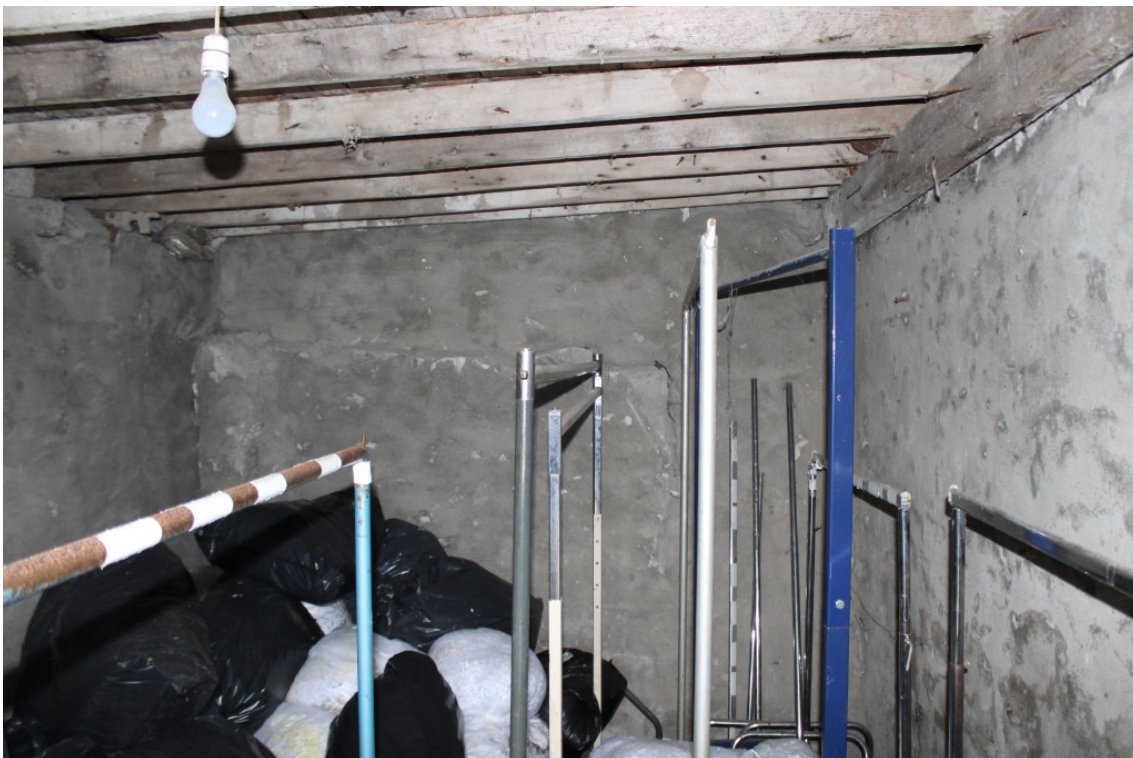
The rear wall of the next two storage units have a sand and cement render finish internally. One unit has a step in the wall while the other has projections at the base of the wall which may have been used as horse feeders.

Area 1 - Internal Face – Note Step in Wall & Cement Render – Taken 24/10/14

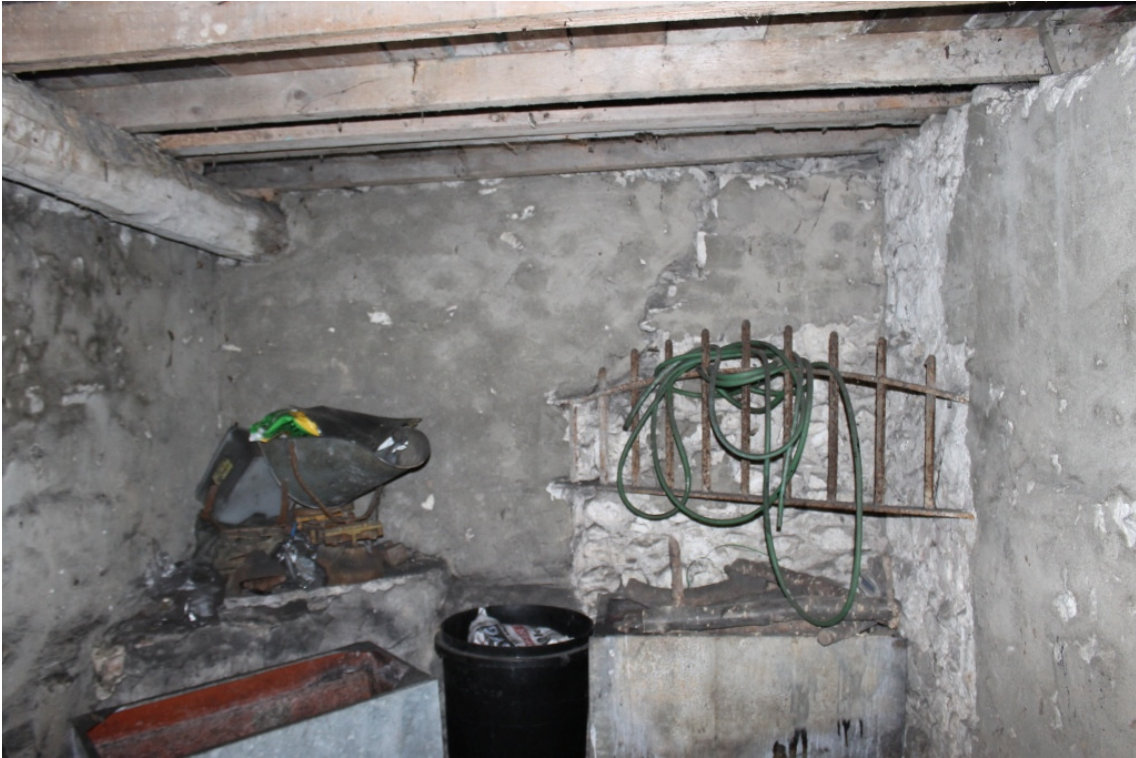
Area 1 - Internal Face – Note Cement Render & Projection in Wall – Taken 24/10/14

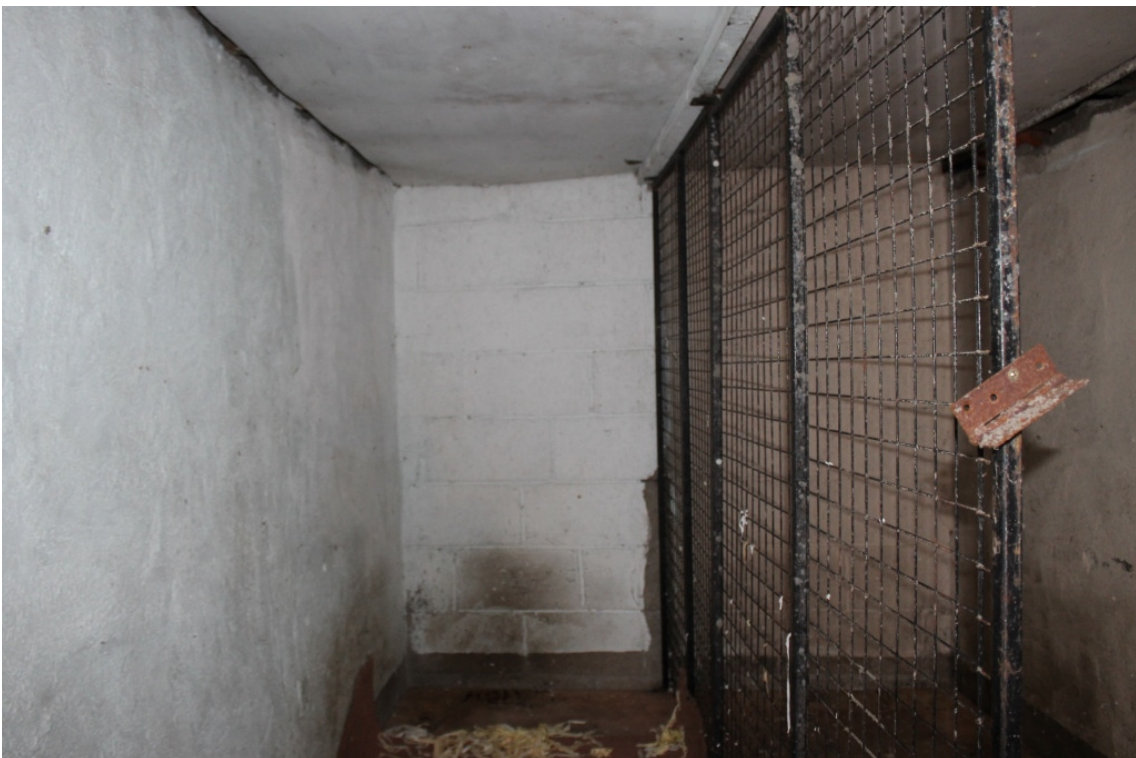
The last, and most northerly, of the four storage units in this building has a masonry block wall constructed internally in front of the Cashel City Wall.

Area 1 - Internal Face – Note Internal block Wall – Taken 24/10/14

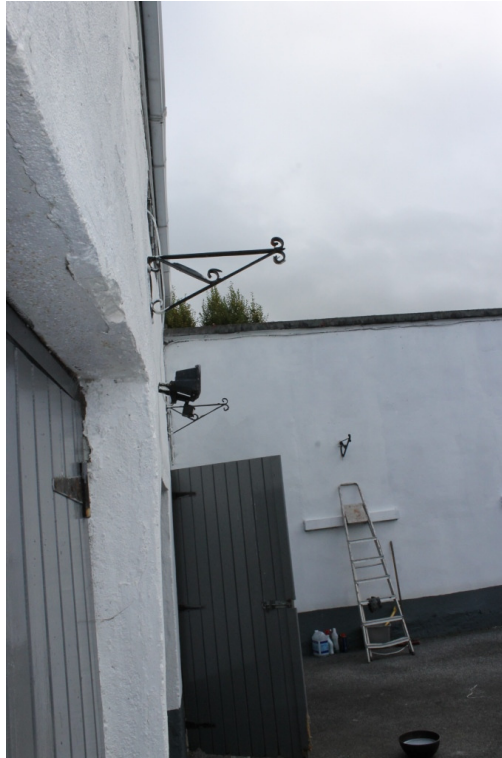
It is worth noting that there is a significant lean outwards in the front wall of this building and deterioration of a number of the door and window opes. Any future movement of this wall has the potential to cause damage to the rear Cashel City Wall as the walls are tied by the roof rafters.

Area 1 – Front Wall of Adjoining Storage Building – Taken 24/10/14

The roof of the storage building provides some lateral restraint to the top of the wall, however, it also poses a danger to the wall as it ties it to the out-of-plumb front wall of the building. Options to reduce this danger include:

- Insertion of a beam to transfer the load from the roof onto the side walls of the building rather than the rear Cashel City Wall.
- Insertion of roof bracing on the underside of the roof joists to transfer any lateral force into the side walls of the building rather than having it transferred directly into the rear Cashel City Wall.

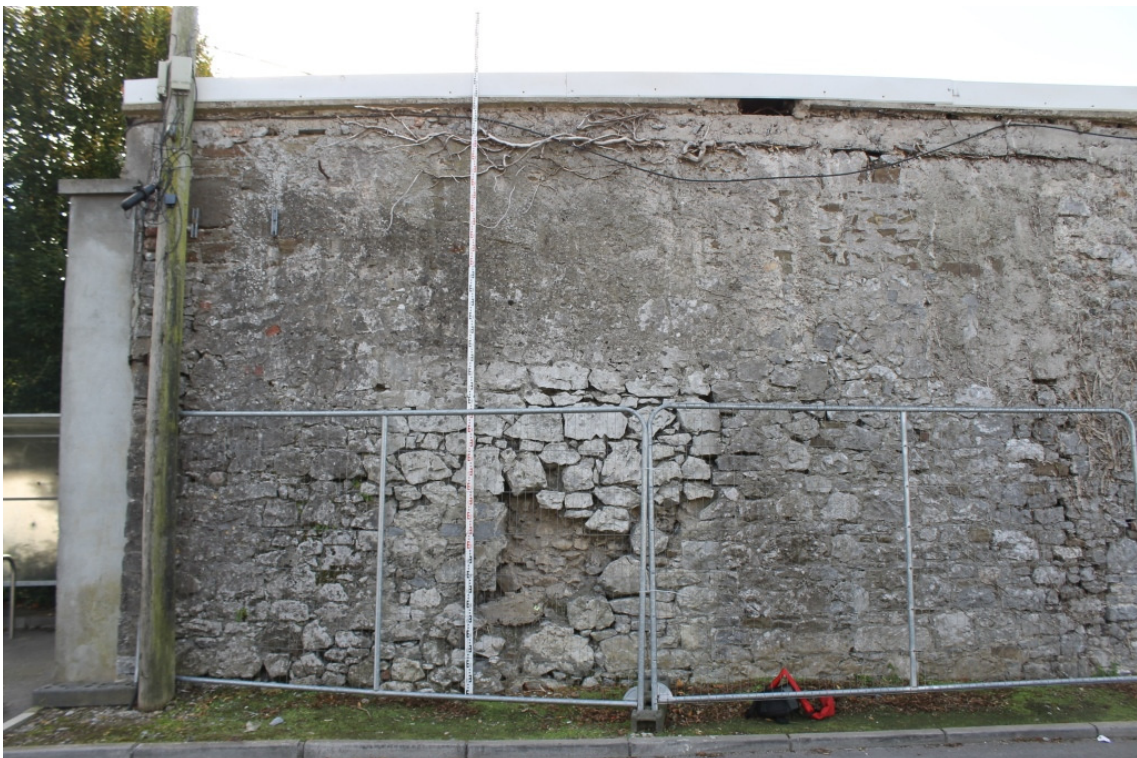
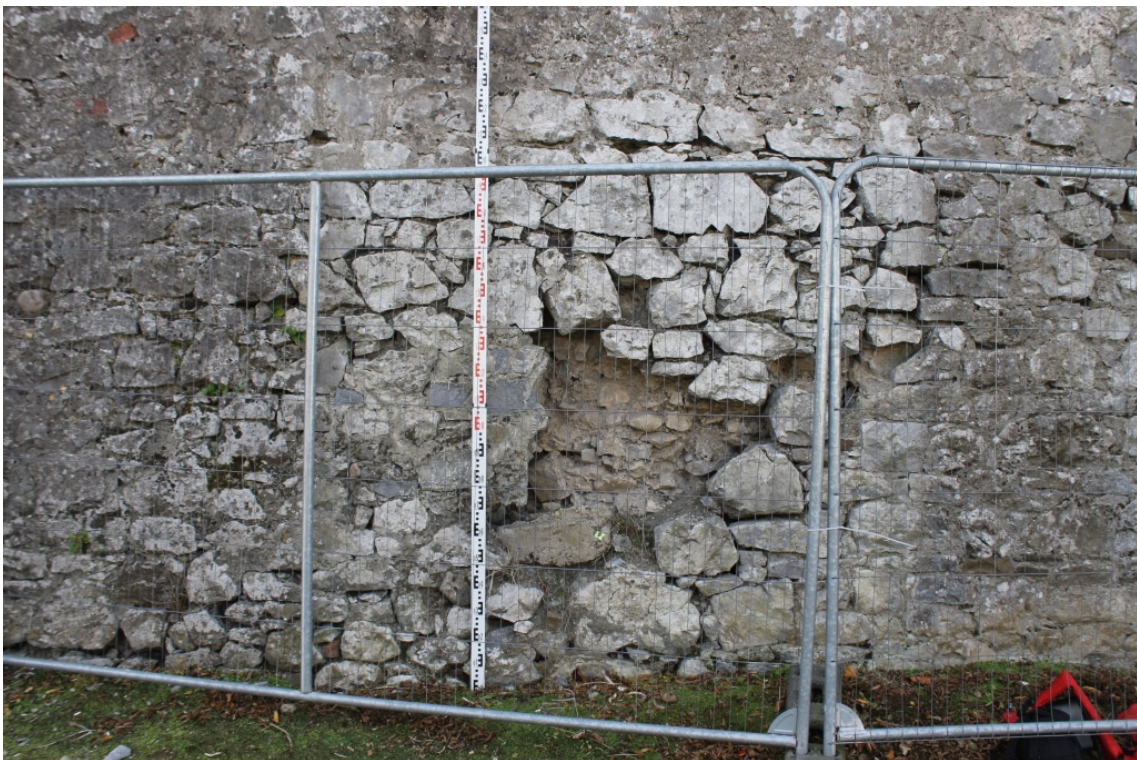
There are stones missing from the outer leaf of an area of wall located 2.5 metres from the southern corner. The area affected is 2 metres long by 1.5 metres high. The joints in the stone over, for a height of approximately 0.75 metres, have opened up with slippage of stones also.

The external face of Area 1 obviously needs urgent attention. It appears as if the stones have been deliberately removed, possibly due to the ease of which they could be removed.

Area 1 – External Face – Taken 24/10/14

In the immediate term, as 'emergency works', we recommend inserting timber sole plates and headers into the existing void, with timber posts between, to support the stone work over the void. Plywood sheathing should then be erected to protect the timber supports and the remaining loose stones.

Following the above 'emergency works', local stone should be sourced of a similar size, texture and colour but un-weathered. This stone should be geologically compatible with the stone in the wall and constructed with a lime based mortar, specification of which should be obtained from Tipperary County Council further to their previous repair projects.

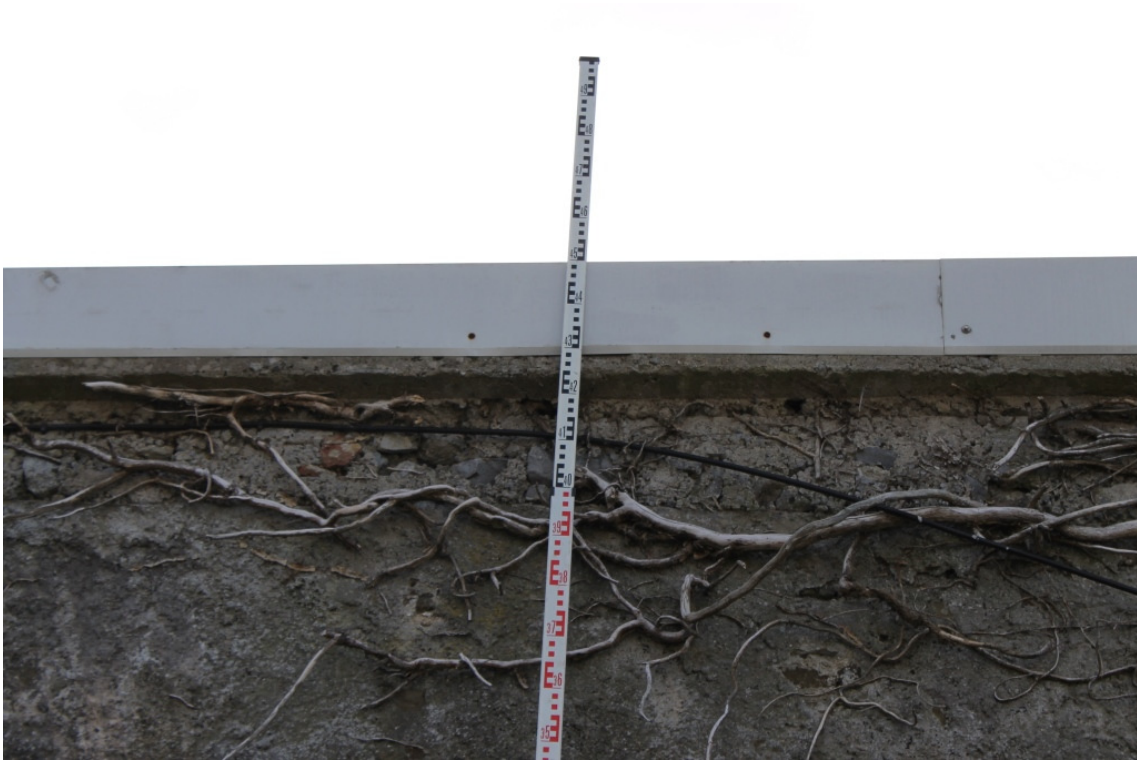
The external face of Area 1 is 4.5 metres high to the top of the storage building roof. There is a pressed metal fascia at the top of the wall and a concrete capping. This section of wall tapers inwards from the bottom to the top.

Area 1 – External Face – Note Concrete Capping and Metal Fascia - Taken 24/10/14

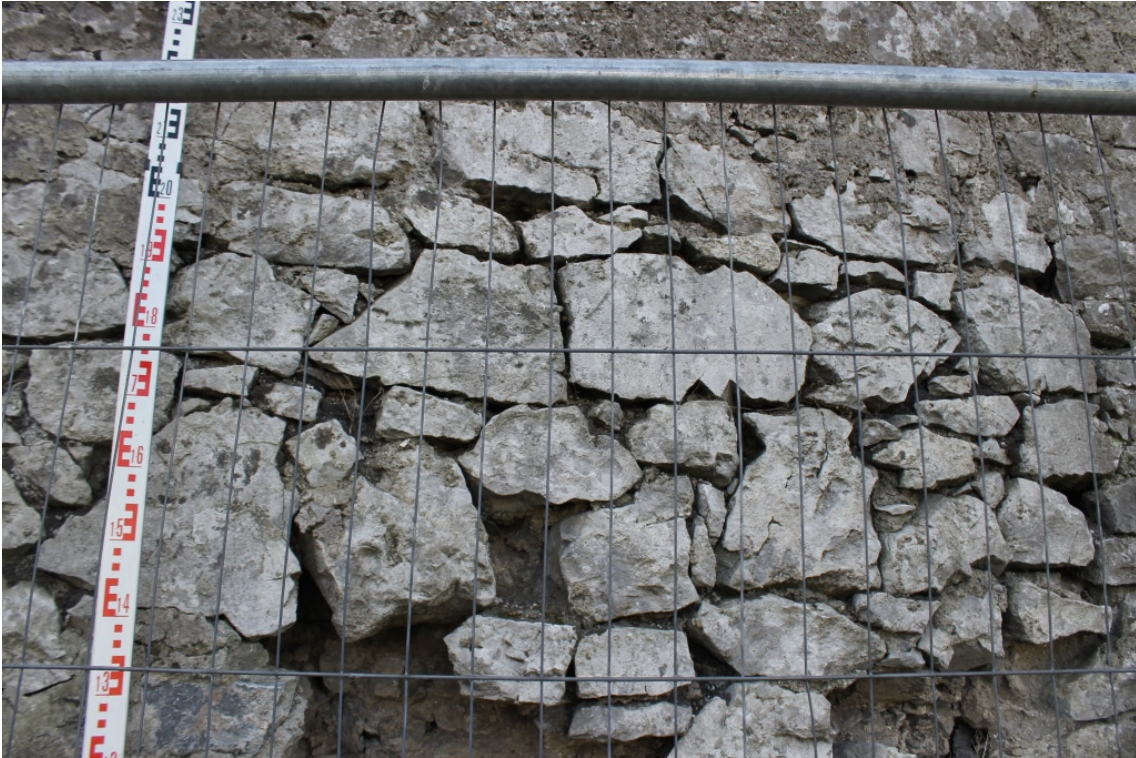
Area 1 – External Face – Note Open Joints Over Void Section - Taken 24/10/14

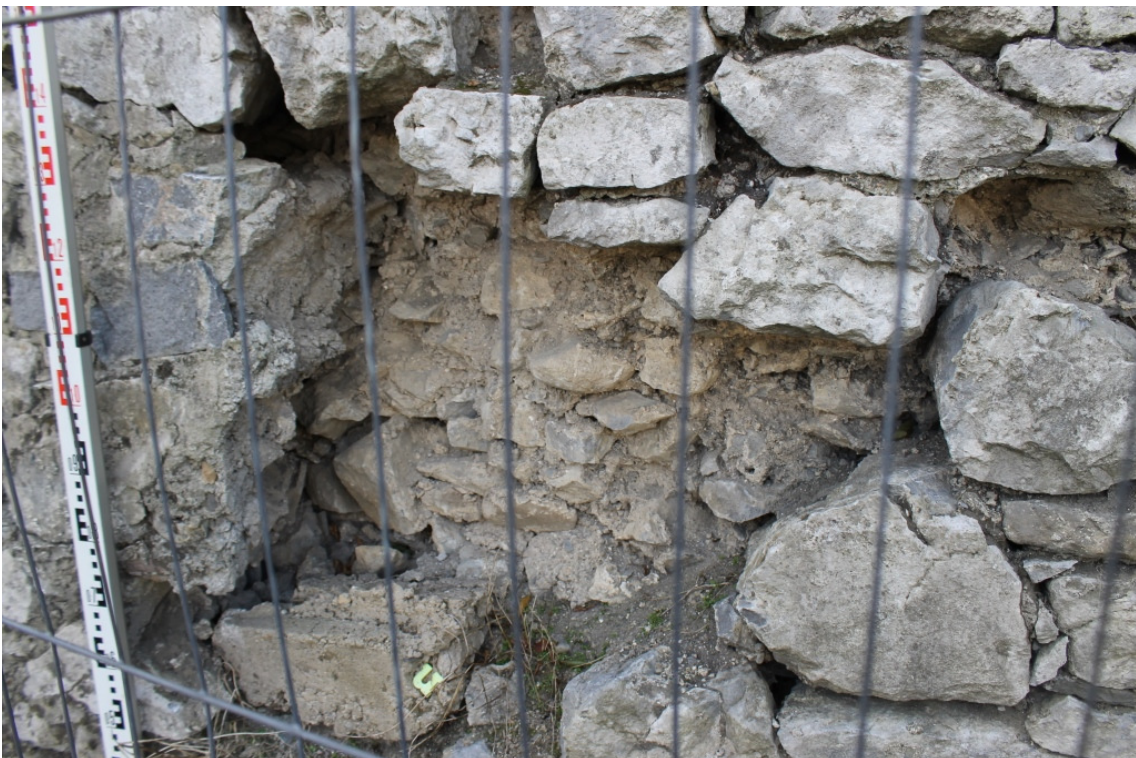
Sections of concrete are evident where the wall was patched in the past inappropriately. Voids were measured in this section of wall up to 0.6 metres deep. There appears to be a cement based render at the top sections of the wall in this location also.

Area 1 – External Face – Note Previous Attempts to Fill Void with Concrete - Taken 24/10/14

As with the internal façade, we would recommend removing a number of pre-selected stones to allow inspection of the core of the wall so an informed decision can be made as to whether grouting in this location of the wall is merited.

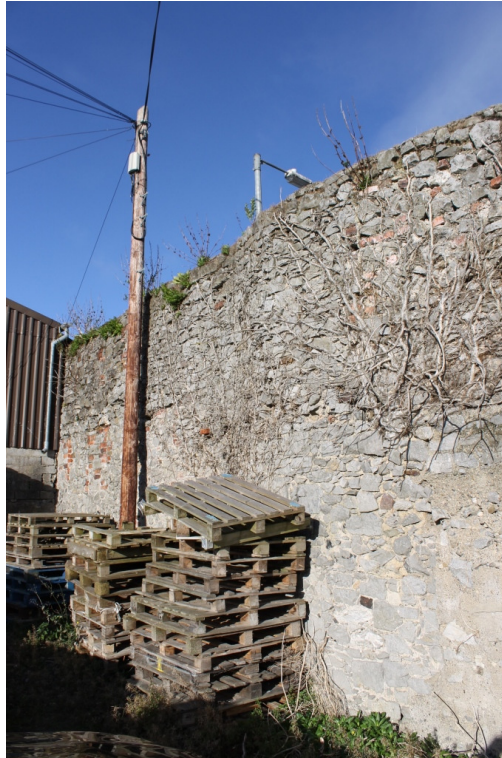
There are significant open joints in the majority of the masonry in this Area. There is a curved section of the wall at high level and significant dead ivy growth. It is apparent that there are significant voids in this section of wall based on the extent of ivy growth out of the wall evident. There are some areas with cement based mortar and others with lime mortar intact. A section of wall as shown in the photos was patched in the past with concrete. There is a vertical crack in the wall in this location also.

Area 2 – Internal Face – Note Dead Ivy Stems - Taken 24/10/14

The dead ivy stems should be carefully removed by hand. The remaining live ivy should be cut at approximately 0.6 metres from the ground for a distance of 0.3 metres and allowed to die. Access should be gained to ascertain the condition of the wall in the private rear gardens on the internal face of Section A of the wall also.

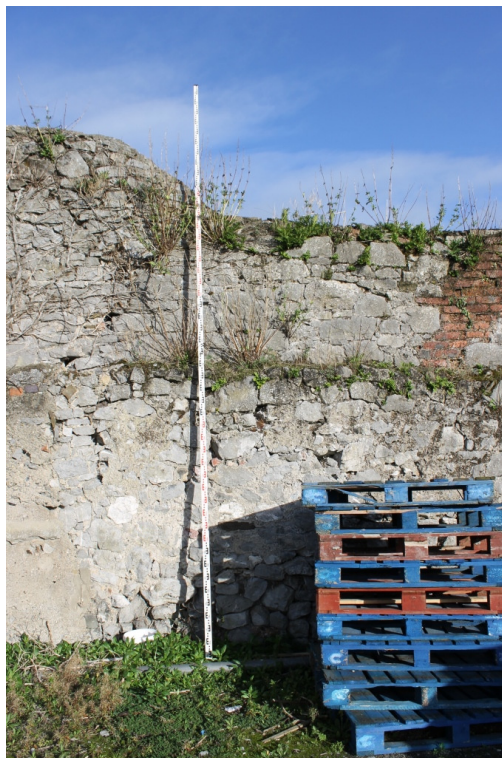
The wall on this façade is 3.6 metres high stepping up to 4.8 metres towards the northern end. There was a step in the wall located approximately 2.2 metres off the ground. This section of wall appears to be out of plumb, leaning inwards. There was a storage shed built to the North of Area 2. Immediately South of this building there were three openings in the Cashel City Wall which were filled in the past with stone rubble masonry and brick. Timber lintels over these openings are significantly decayed and forming voids.

Area 2 – Internal Face – Note Dead Plant Growth Along Step - Taken 24/10/14

A rounded hydraulic lime mortar capping should be cast on top of the wall and the areas of concrete capping carefully removed. A similar capping could be provided at the step location also to stop the water penetrating into the core of the wall.

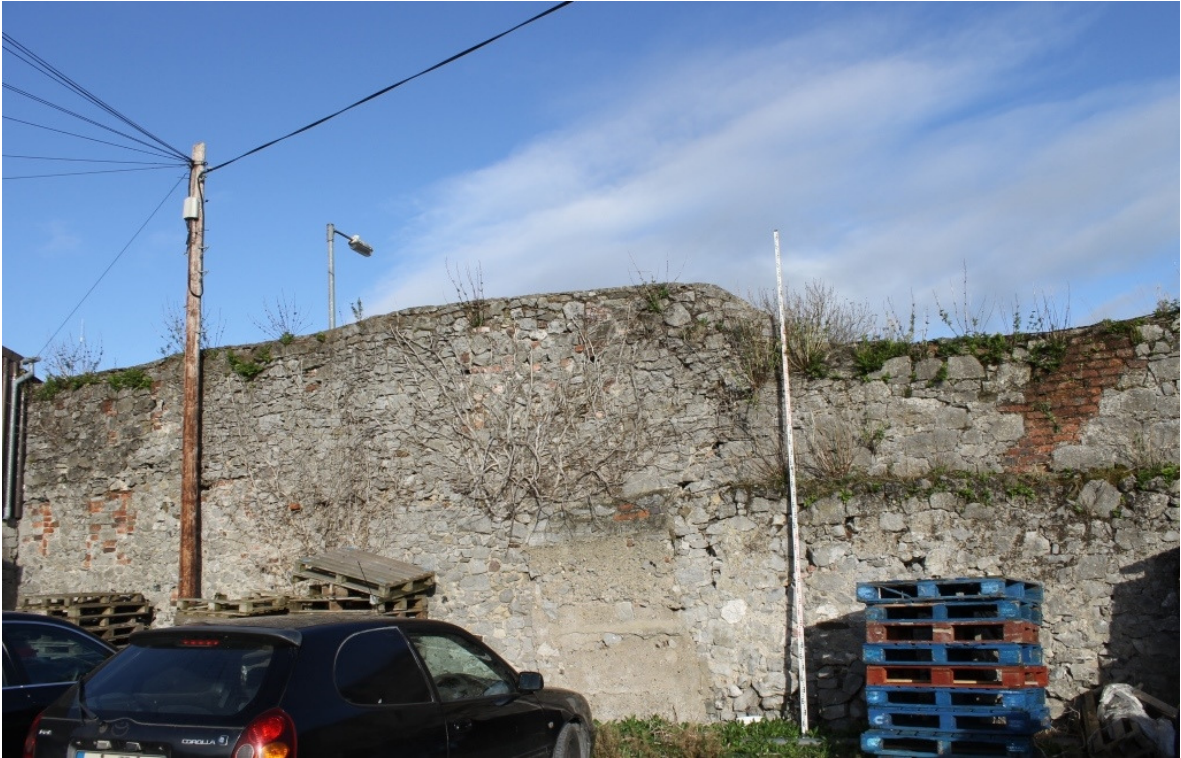
Area 2 – Internal Face – Note Concrete patching to Left of Staff - Taken 24/10/14

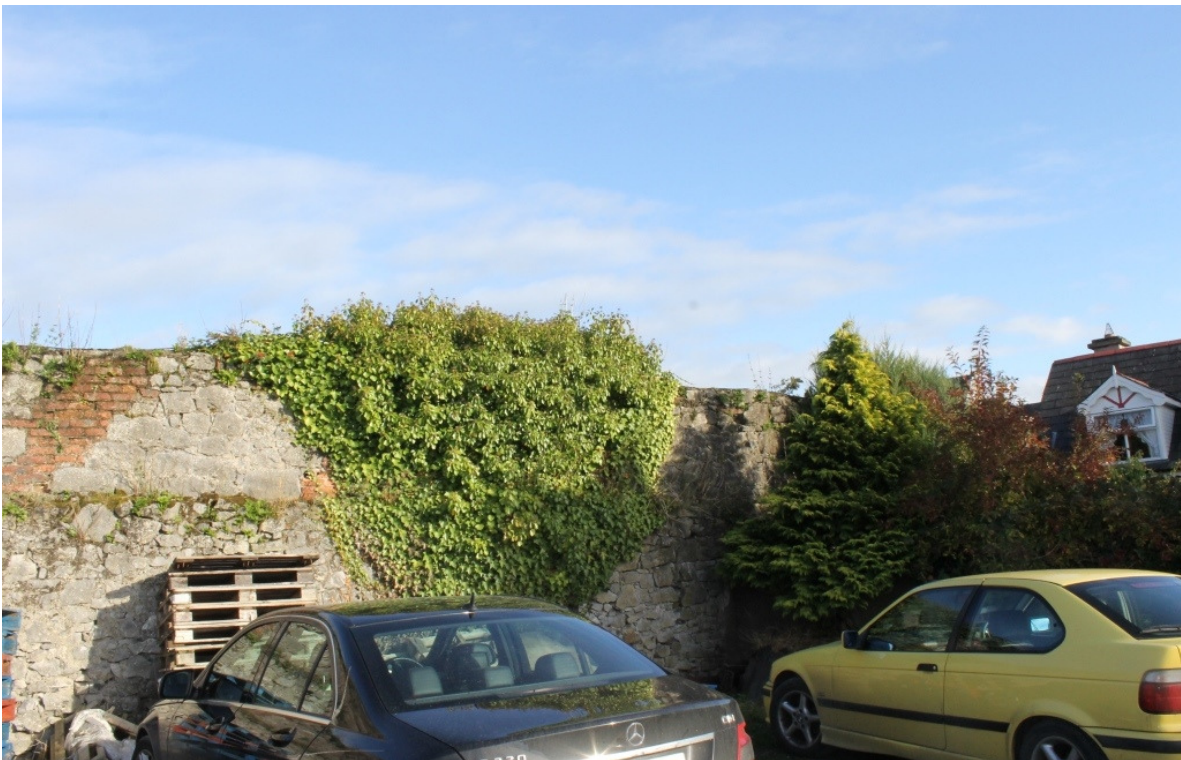
There is live ivy growth to the South of Area 2 and the wall in the garden to the South of the car-park appears to be out-of-plumb and containing significant open joints, although access was not gained to this area.

Area 2 – Internal Face – Note Ivy Growth and Proximity of Tree - Taken 24/10/14

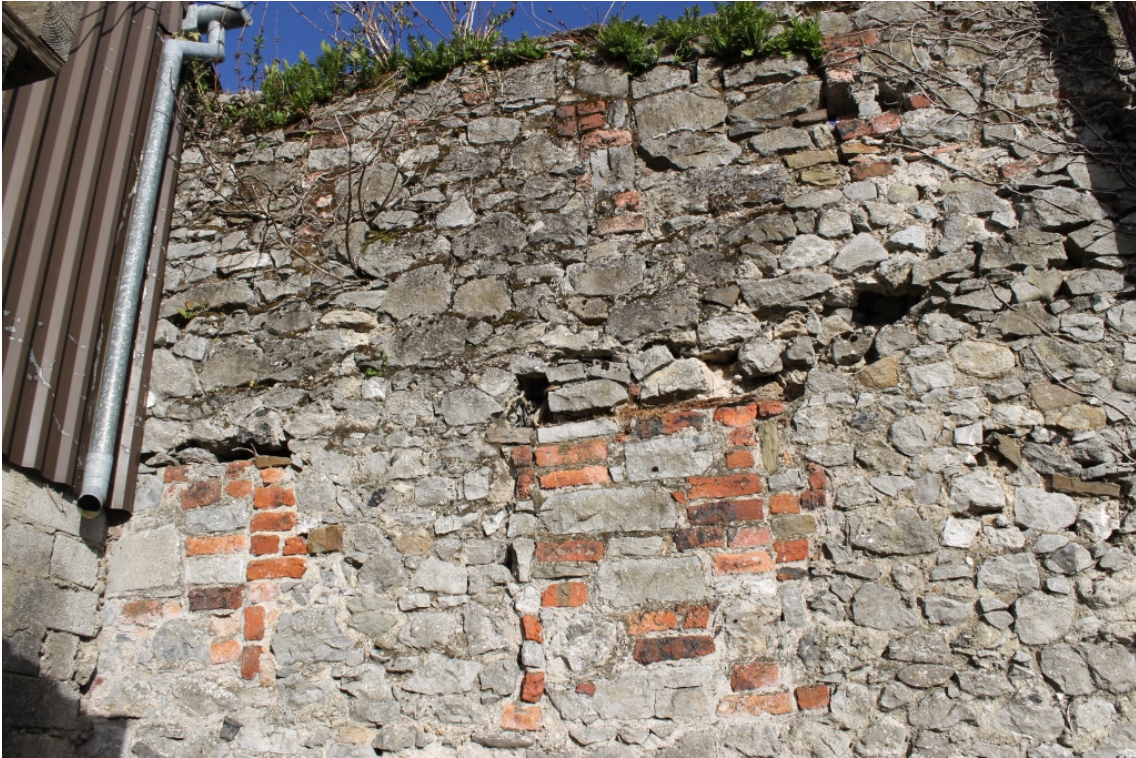
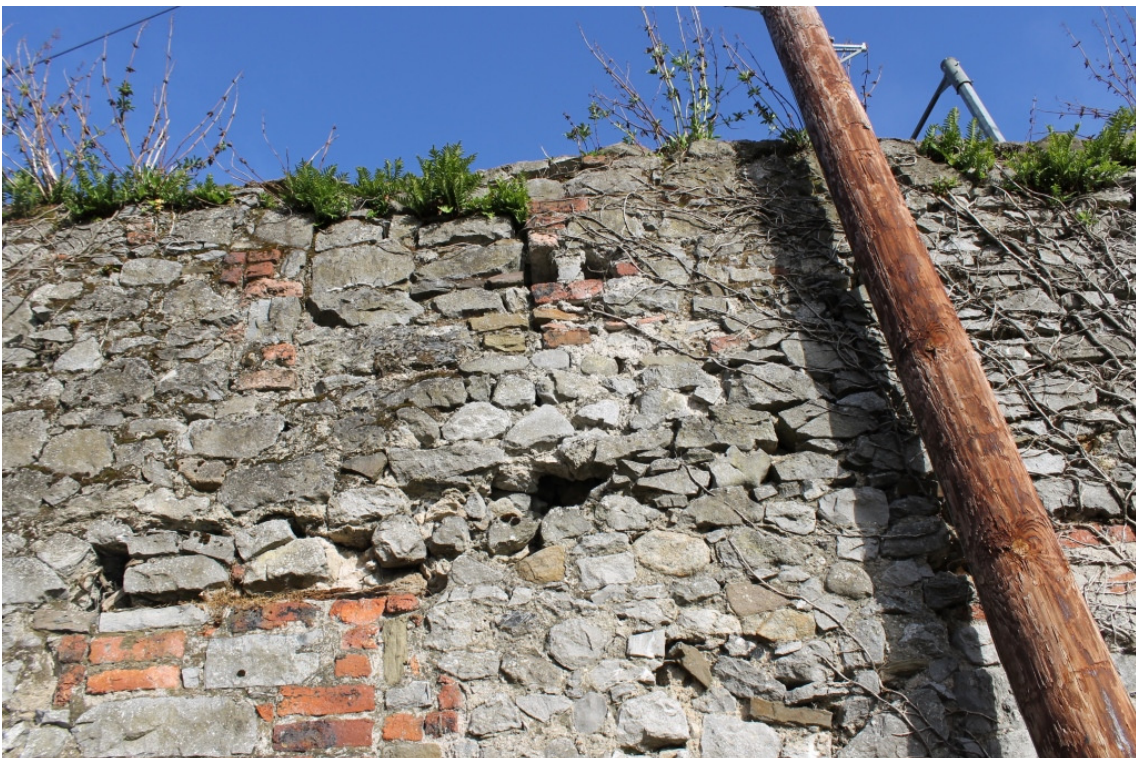
Area 2 – Internal Face – Note Filled Openings and Downpipe - Taken 24/10/14

Area 2 – Internal Face – Note Filled Openings and Timber Lintel - Taken 24/10/14

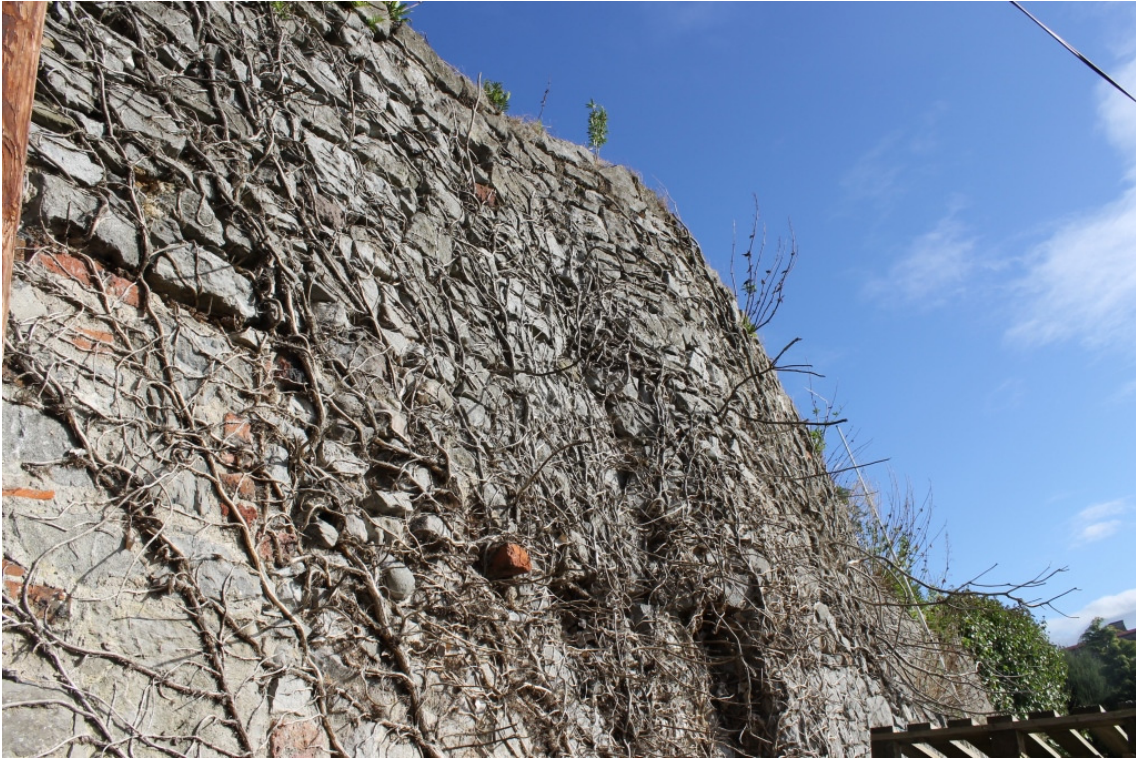
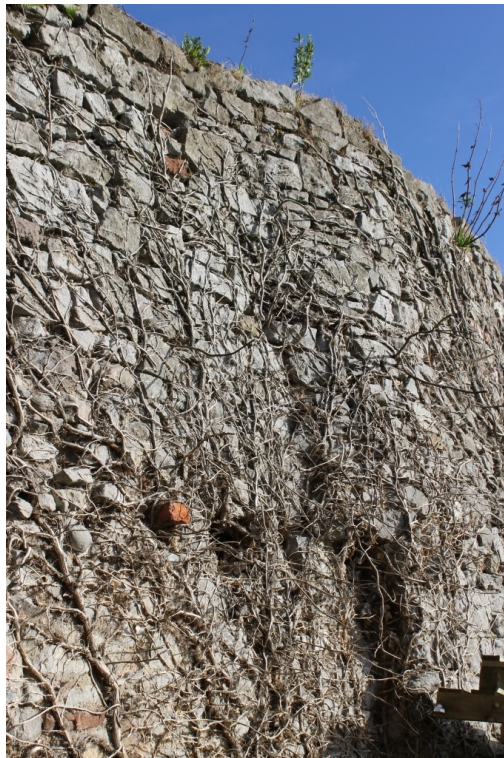
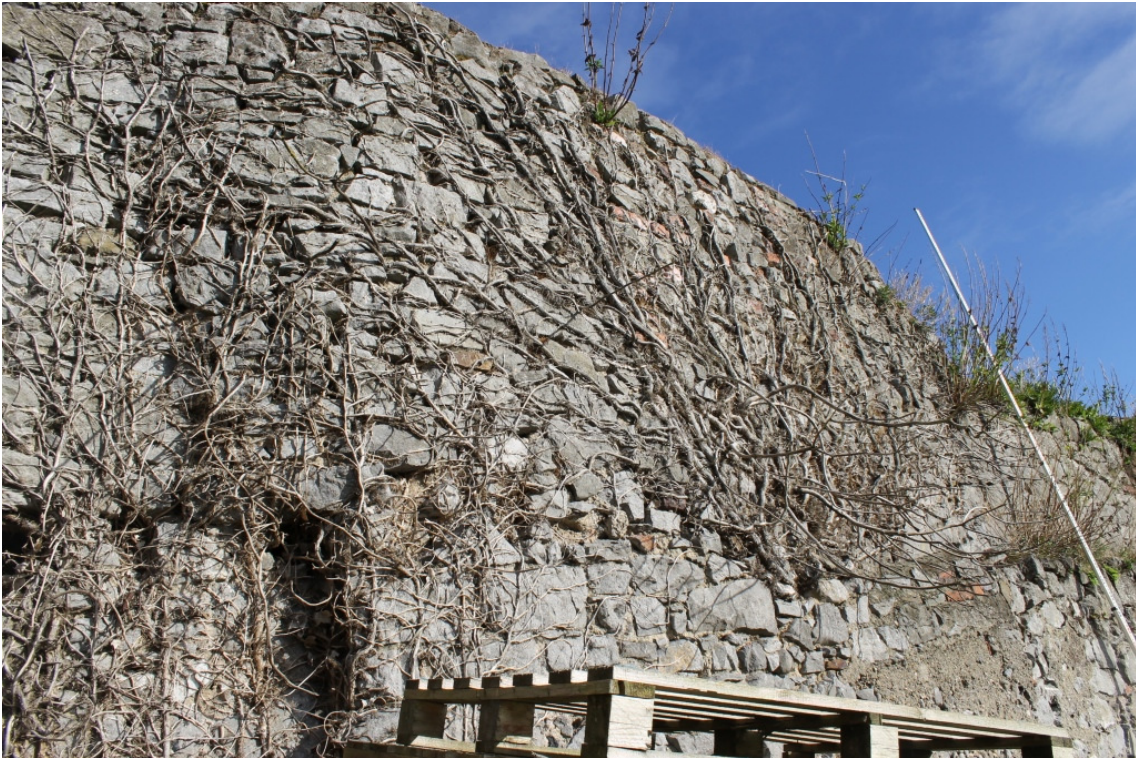
Area 2 – Internal Face – Note Curved Section of Wall and Dead Ivy - Taken 24/10/14

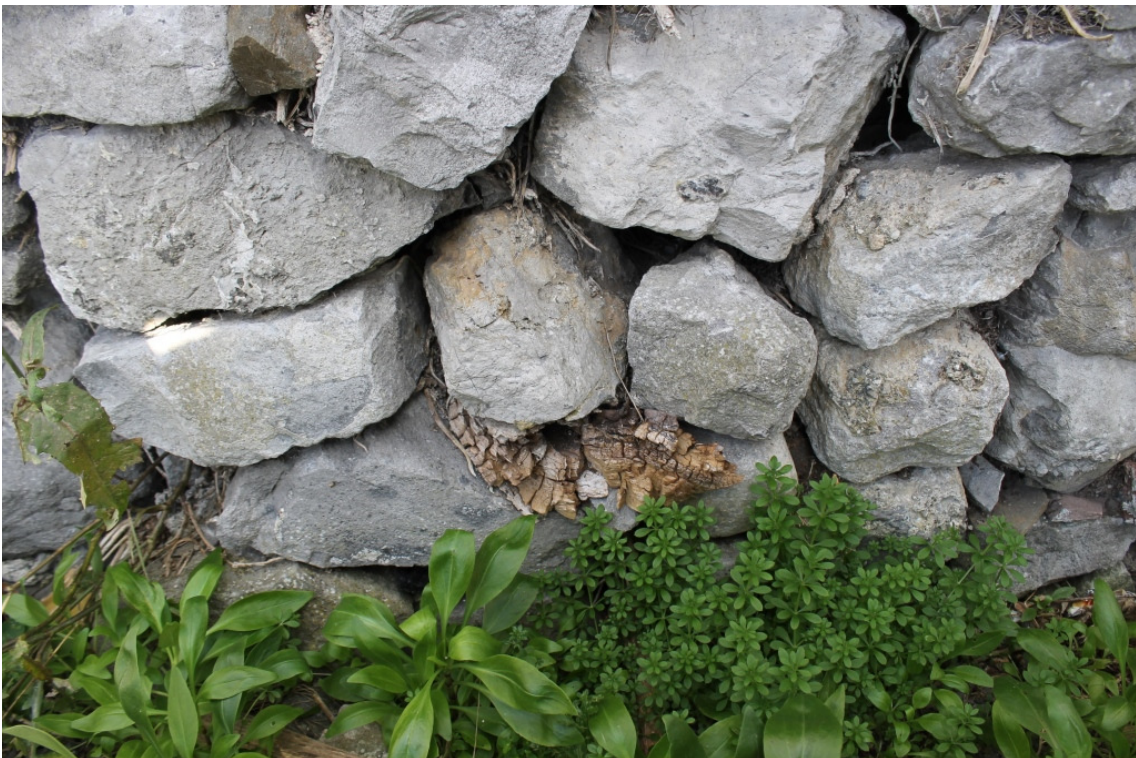
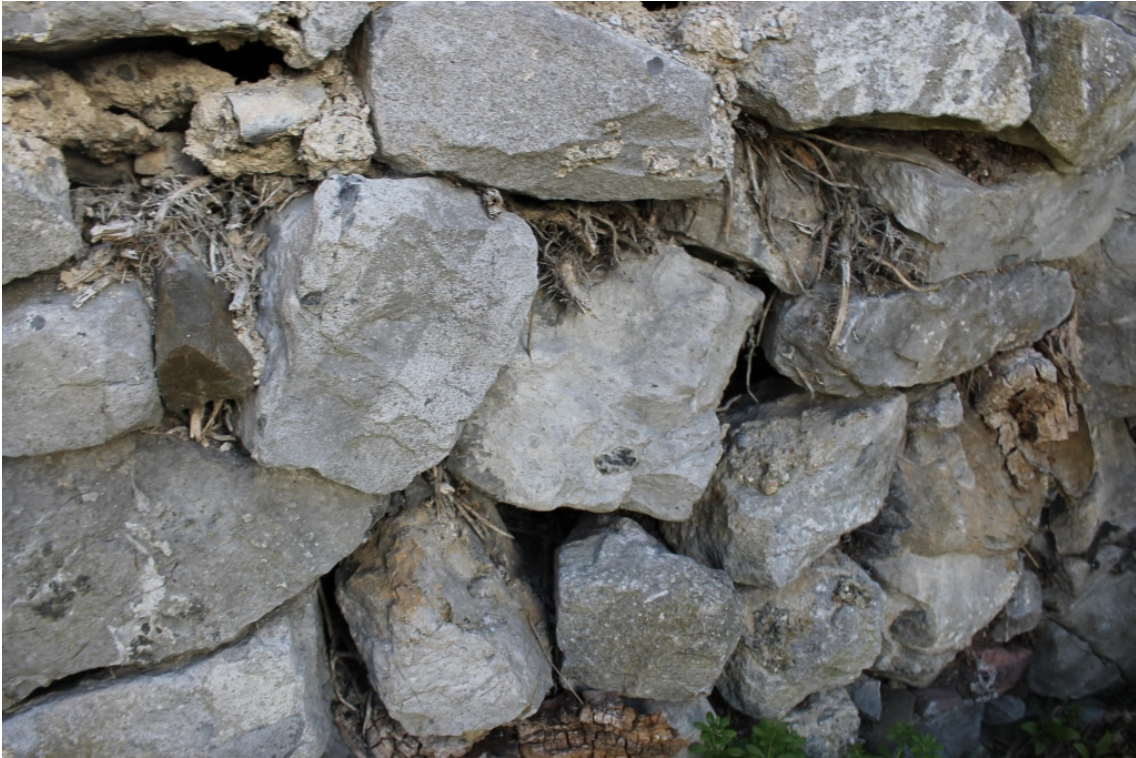
There are extensive amounts of woody Ivy stems present in the wall at Area 2. It is assumed that there is significant voiding in this section of wall as a result. This casts a doubt over the short term stability of the wall in this location. Furthermore, it was difficult to ascertain the scale of 'plumbness', or otherwise, of the wall from the ground during our visual inspection. This, along with the wall thickness, will be required to try ascertain the overall stability of the wall. This information can be attained in a number of ways as follows:

Area 2 – Internal Face – Note Woody Ivy Stem & Open Joints - Taken 24/10/14

Area 2 – Internal Face – Note Woody Ivy Stems & Open Joints - Taken 24/10/14

Following determination of the stability of the wall with regard to 'plumbness', the wall will need to be either grouted and consolidated or re-constructed.

The requirement for grouting shall follow the specification below with stones removed at approximately 1 metre centres vertically and horizontally to allow access to grout by gravity. Specific stones to be removed should be identified by a suitably qualified consultant.

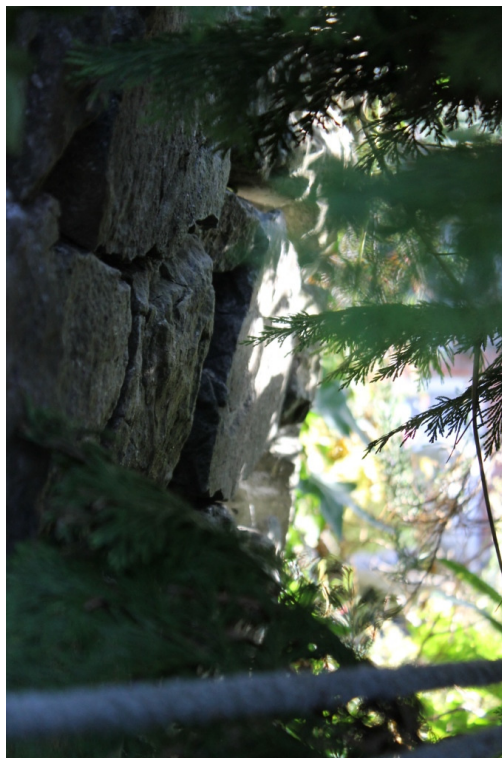
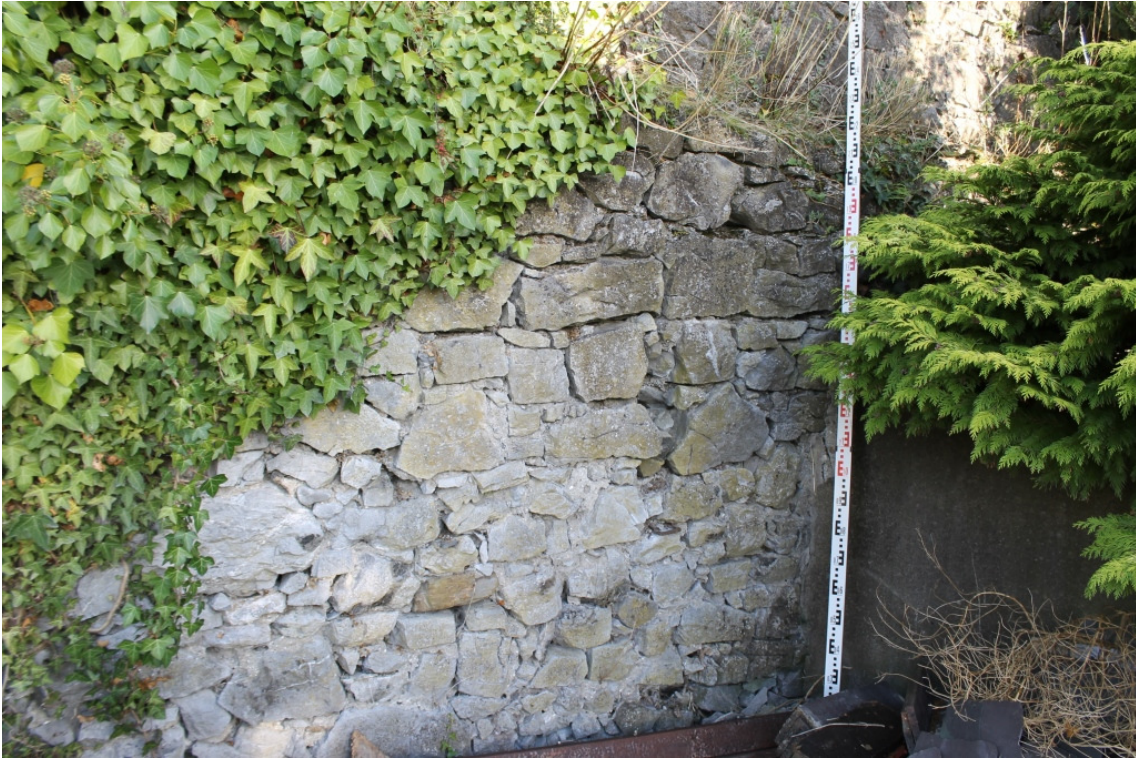
Area 2 – Internal Face – View of Wall in Garden to South of Carpark - Taken 24/10/14

Area 2 – Internal Face – View of Wall to South of Area 2 – Note Open Joints - Taken 24/10/14
