Conservation Methodology Report

Cashel City Walls 2014 Defects at Section A (Roselawn Close), Cashel, Co. Tipperary.

**Client:
Cashel Town Council,
Town Hall,
Friar Street,
Cashel,
Co. Tipperary.**

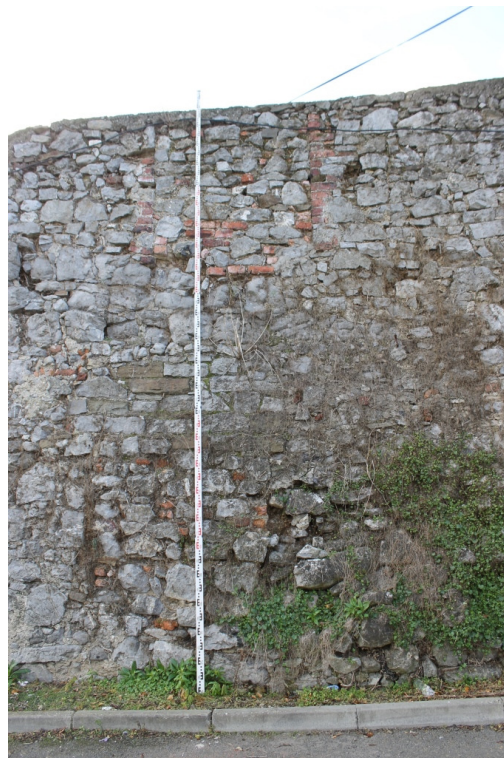
Area 2 – External Face - Taken 24/10/14

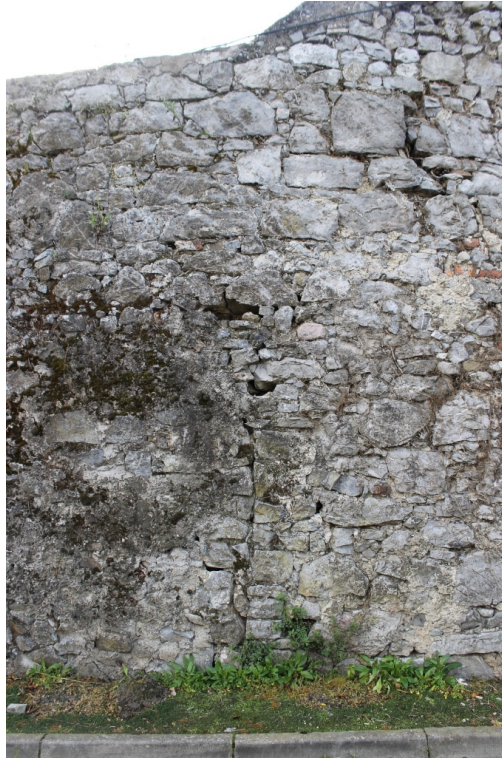
Area 2 – External Face – Note Step in Wall and Possible Previous Opening – Taken 24/10/14

A rounded hydraulic lime mortar capping should be cast on top of the wall and the areas of concrete capping carefully removed. A similar capping could be provided at the step location also to stop the water penetrating into the core of the wall.

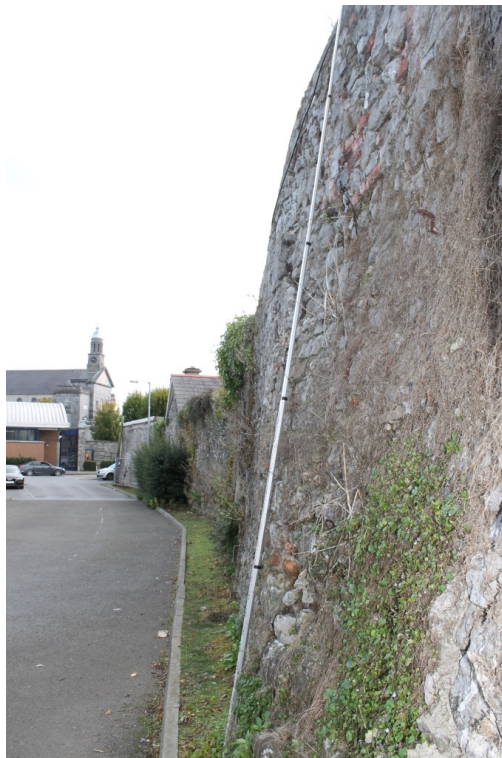
The external face of Area 2 faces on to Roselawn Close. There is a significant taper/lean in the wall in this location leaning inwards into the car-park on the internal side of the wall.

Area 2 – External Face – Note Taper/Lean in Wall – Taken 24/10/14

- Provision of access to the top of the wall by means of scaffolding to allow the use of a plumb line. Scaffolding should be provided rather than a hoist as accurate measurements with a plumb line are weather dependant and therefore a scaffolding in place allows flexibility with the day they are to be taken. Also, scaffolding allows for a platform to carry out opening up works to determine the extent of grouting required to fill the voids in the wall core.
- A 3D Point Cloud Survey can be undertaken on both sides of the wall. From this, sections can be generated to give the different thicknesses of the wall and identify areas where the wall may be significantly out-of-plumb. This is an expensive service however and does not have the advantage of providing a platform for investigative opening up works.

Following determination of the stability of the wall with regard to 'plumbness', the wall will need to be either grouted and consolidated or re-constructed.

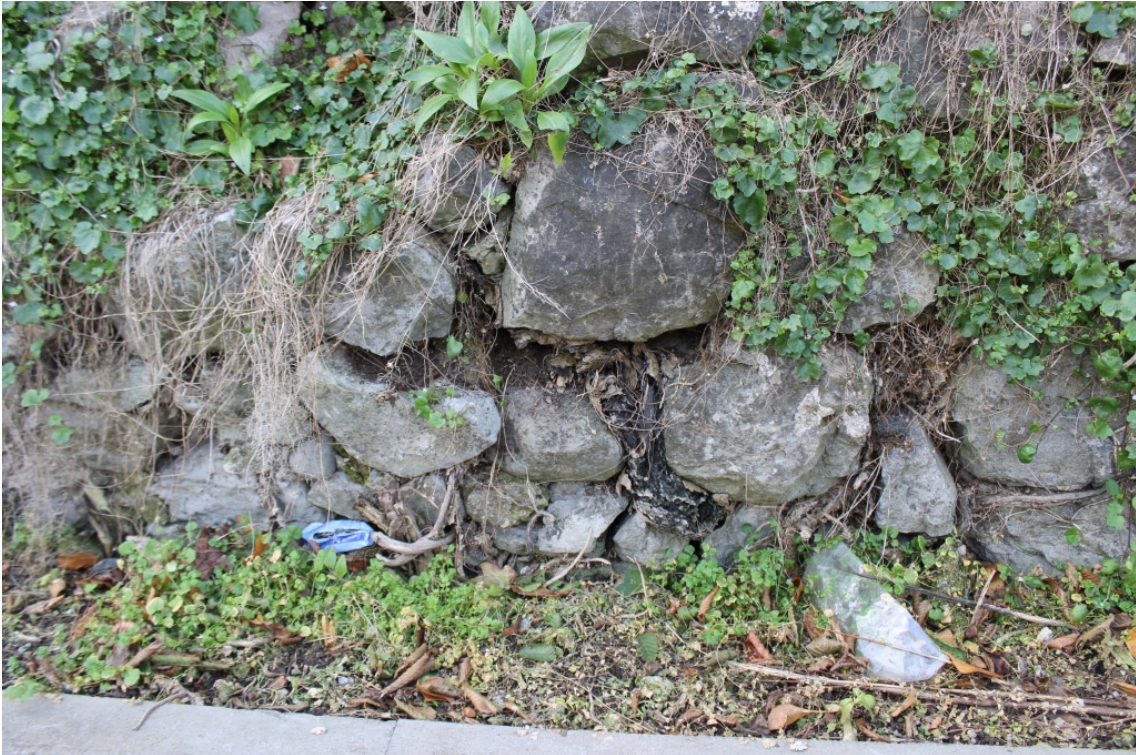
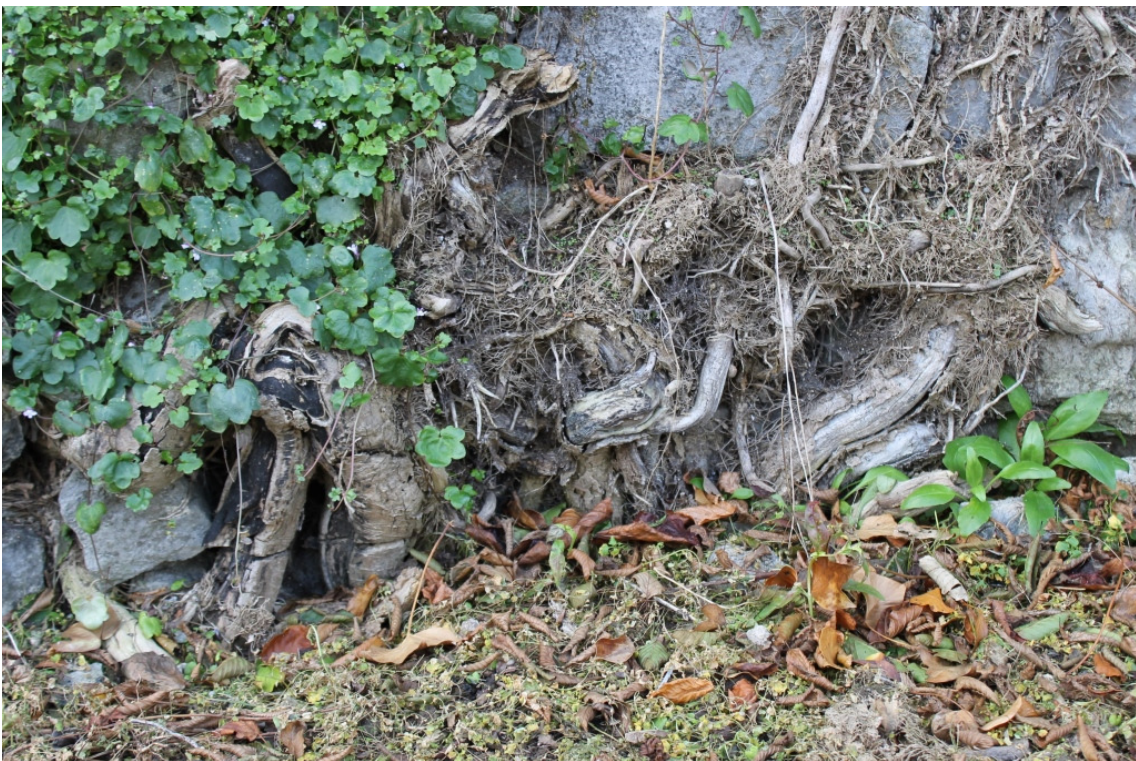
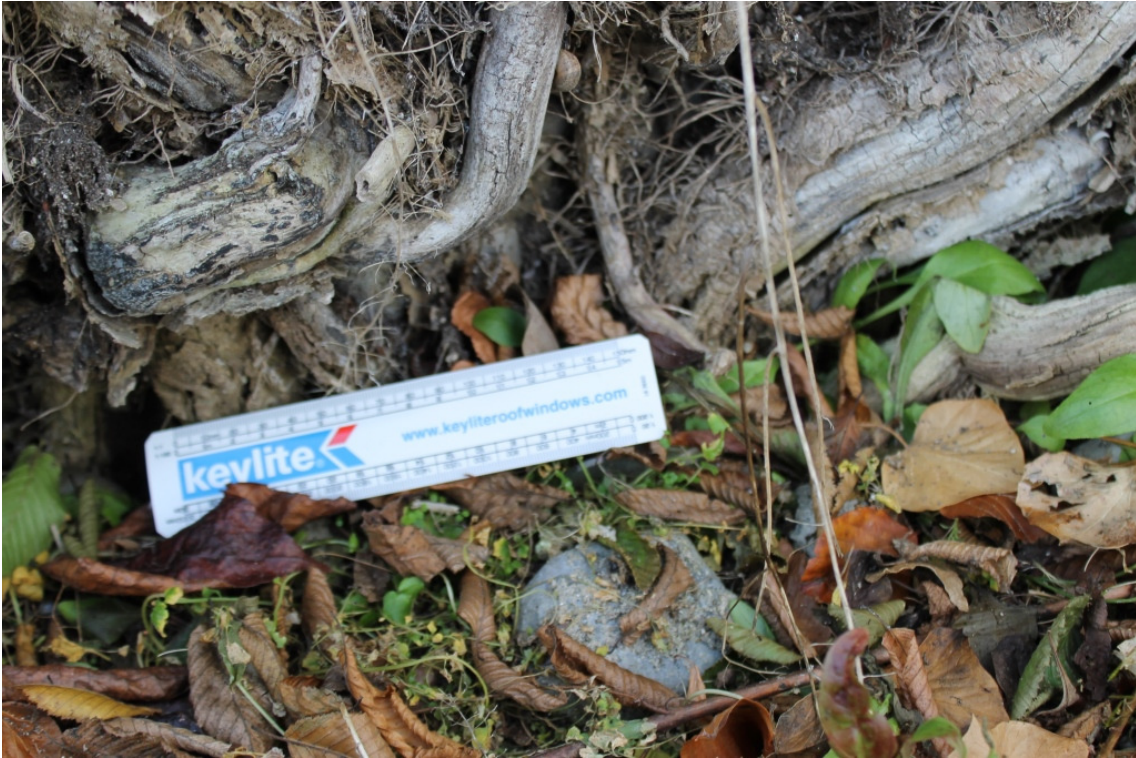
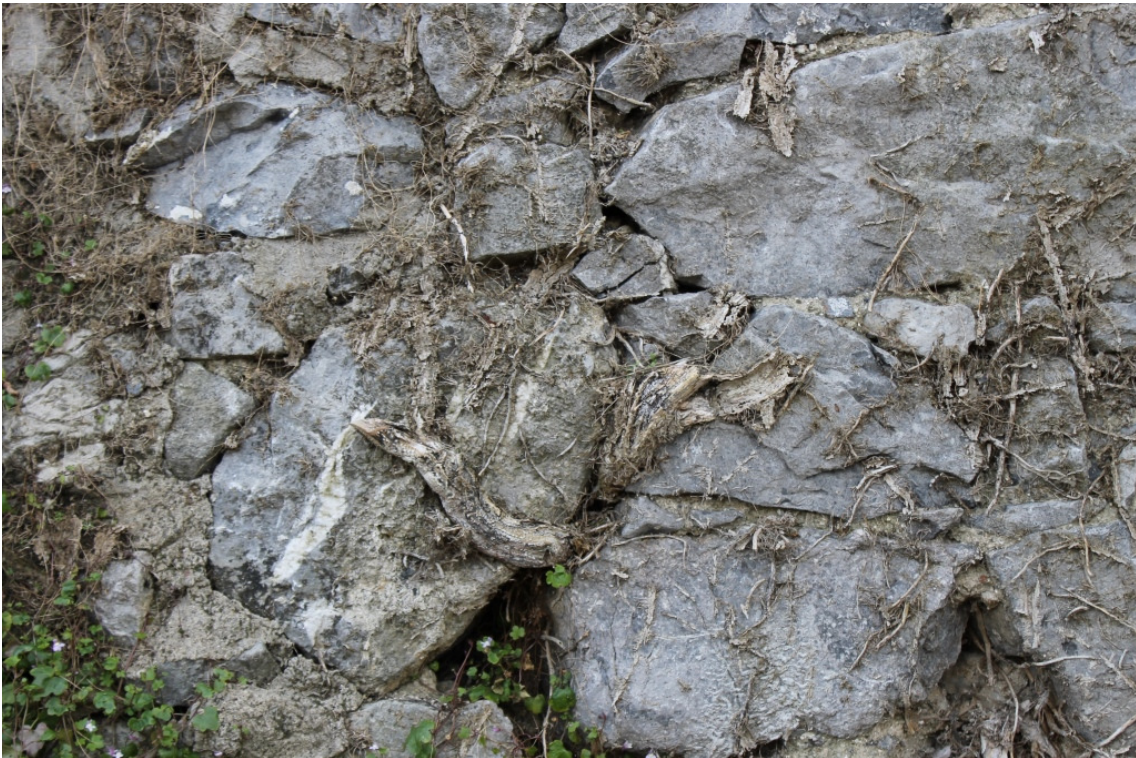
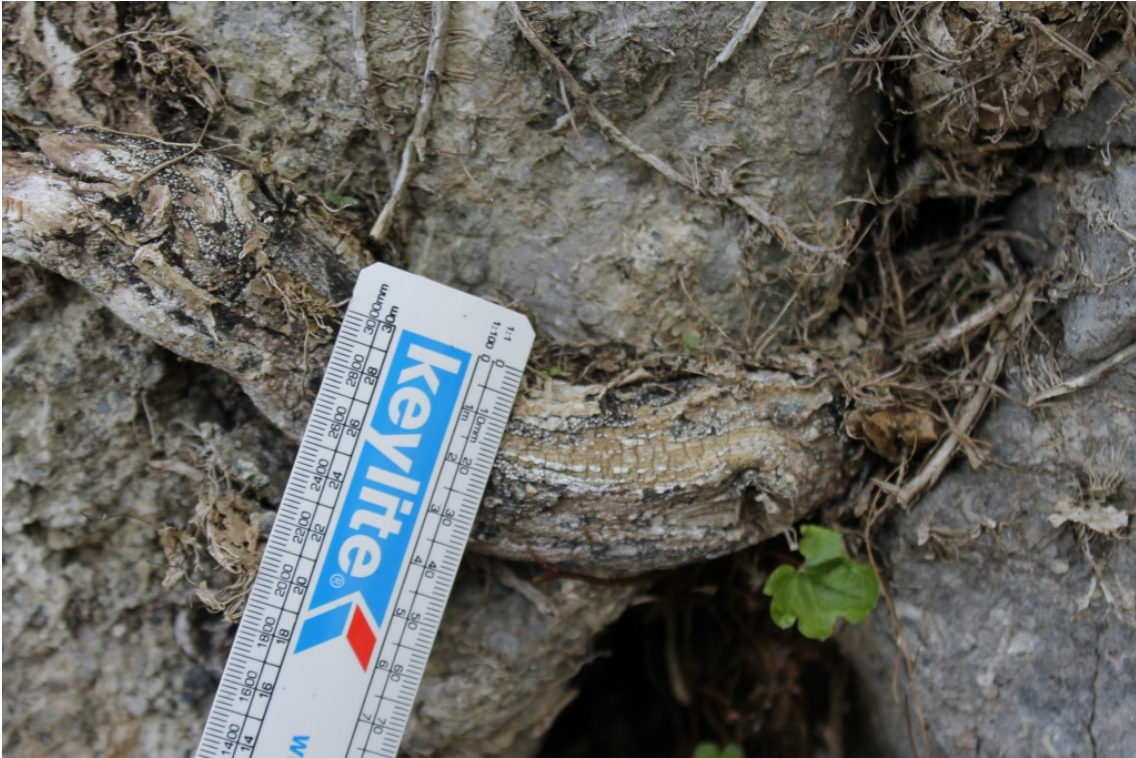
At the base of this wall there are loose stone units. There are extensive areas of dead ivy also with stems up to 50 millimetres in diameter a common occurrence.

There are extensive amounts of woody Ivy stems present in the wall at Area 2. It is assumed that there is significant voiding in this section of wall as a result. This casts a doubt over the short term stability of the wall in this location. Furthermore, it was difficult to ascertain the scale of 'plumbness', or otherwise, of the wall from the ground during our visual inspection. This, along with the wall thickness, will be required to try ascertain the overall stability of the wall. This information can be attained in a number of ways as follows:

Area 2 – External Face – Note Significant Ivy Stem in Wall – Taken 24/10/14

The dead ivy stems should be carefully removed by hand. The remaining live ivy should be cut at approximately 0.6 metres from the ground for a distance of 0.3 metres and allowed to die. Access should be gained to ascertain the condition of the wall in the private rear gardens on the internal face of Section A of the wall also.
