**COMPLETION REPORT:**

**CONSERVATION WORKS 2019**

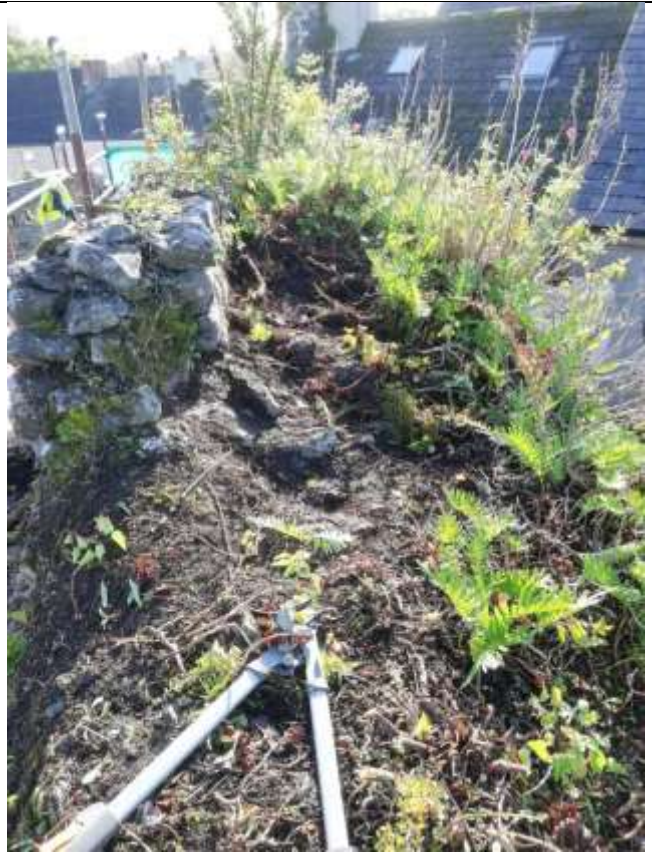
x. Significant levels of soil build-up were found once vegetation was removed from the top of the wall – progress photo October 2019

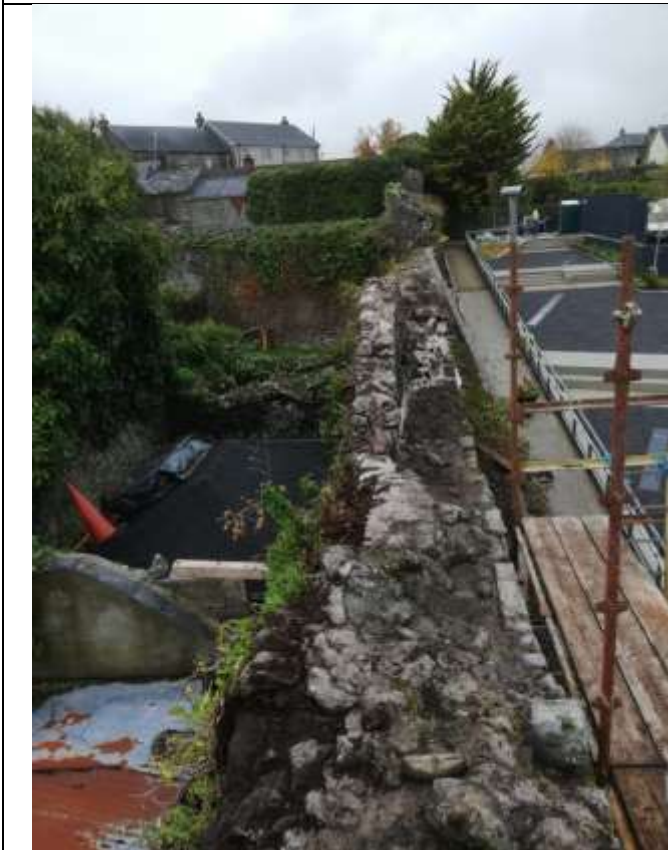
X1. View along top of wall (looking north) with vegetation removed – progress photo October 2019

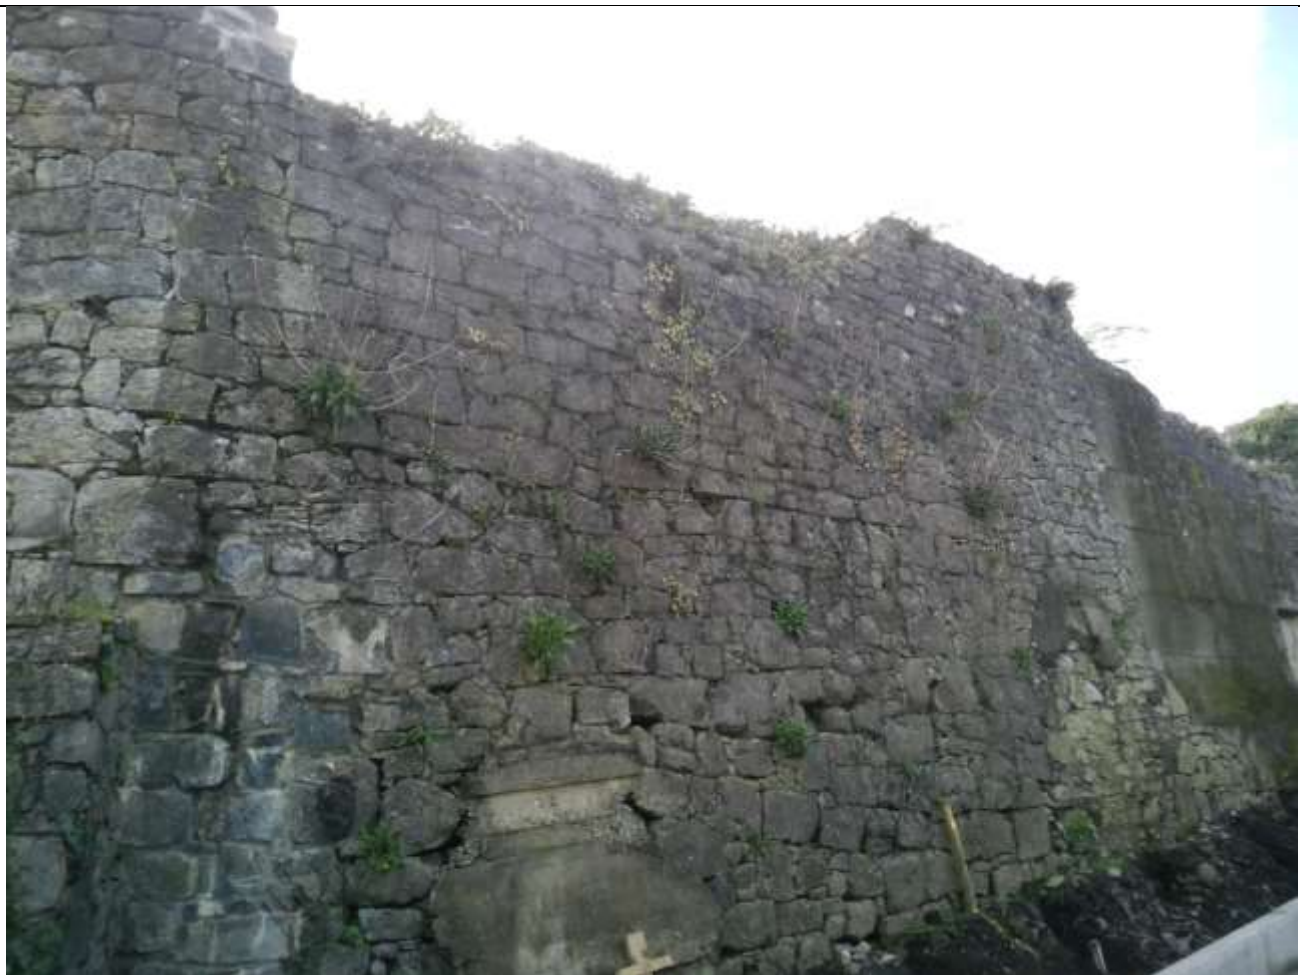
2. This photograph (prior to the works) shows the southern part of the subject wall (northeast face), viewed from within the new park. There are areas of missing mortar, together with gaps and cavities associated with missing stones.

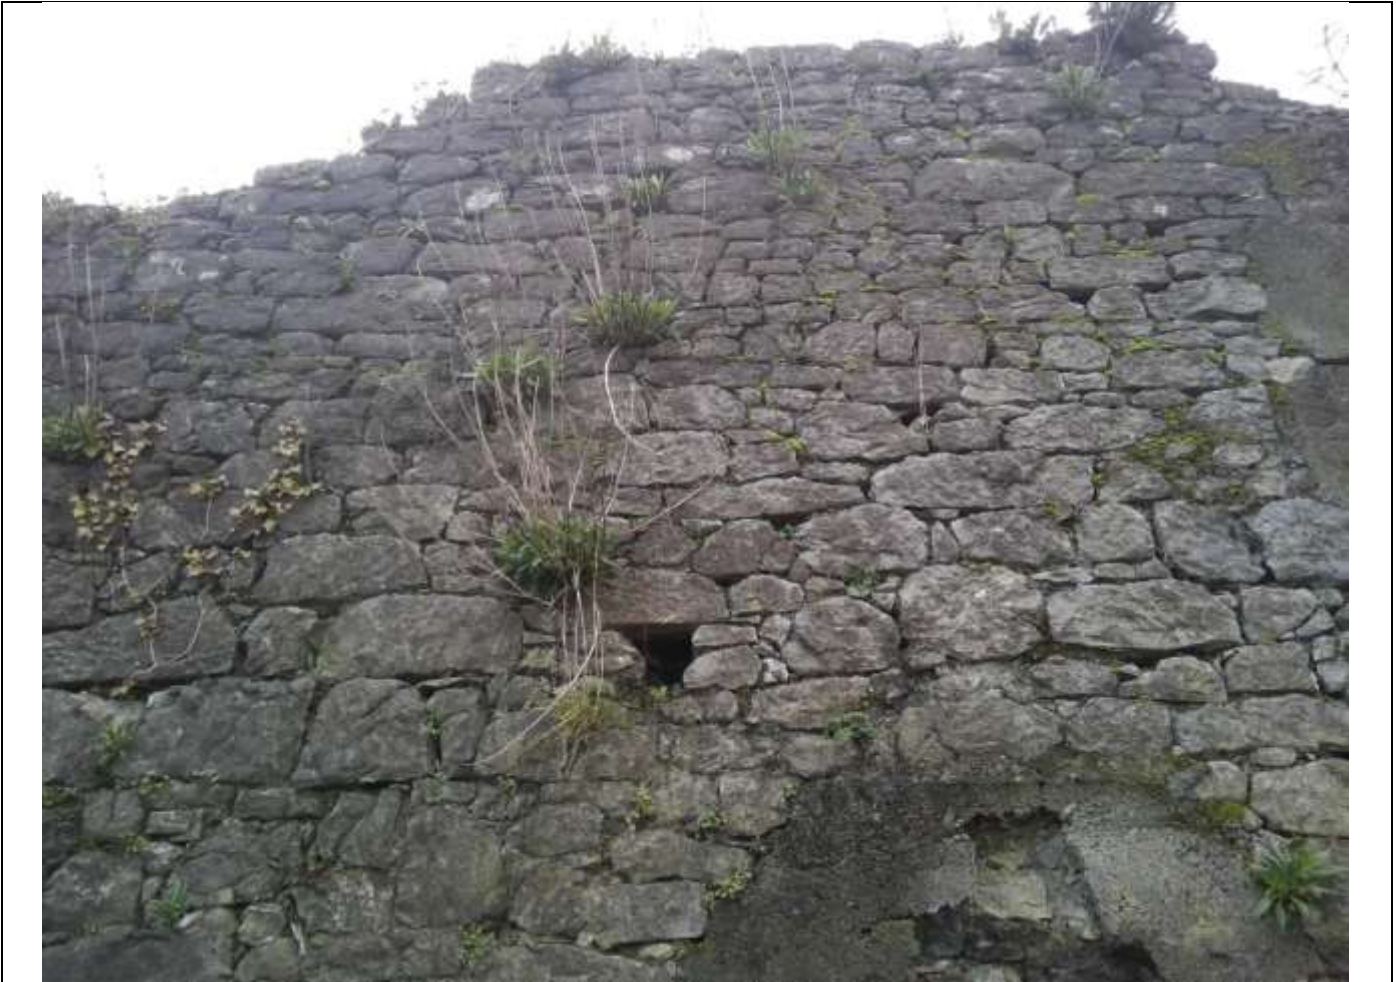
3. Detail of south part of subject wall (close to Burke Street) prior to works. The haunching at the top of the wall has broken down with colonisation by buddleia and ivy. There are loose and unstable stones along the top of the wall.

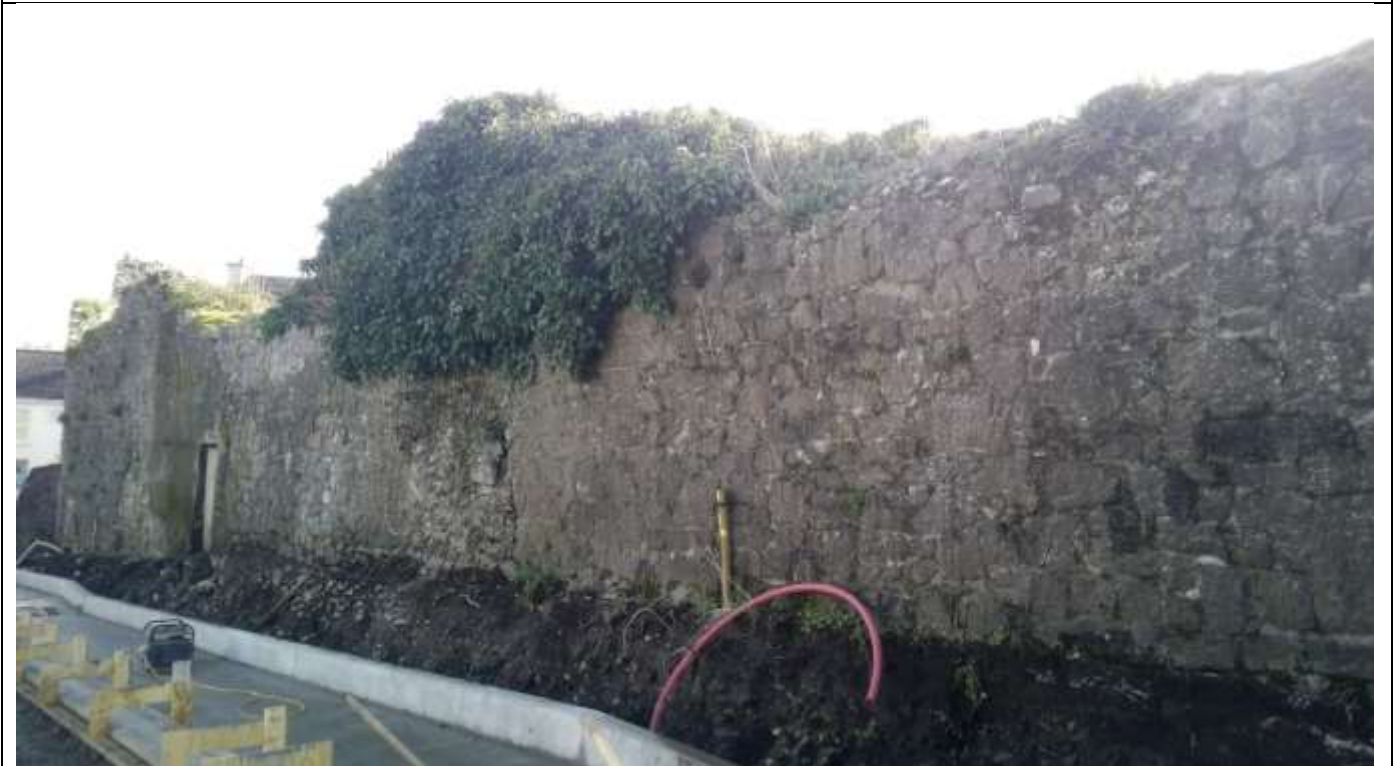
4. Significant ivy growth and vegetation on upper part of wall. This vegetation threatens the fabric of the wall and is to be removed in tandem with the re-pointing and consolidation of the wall.

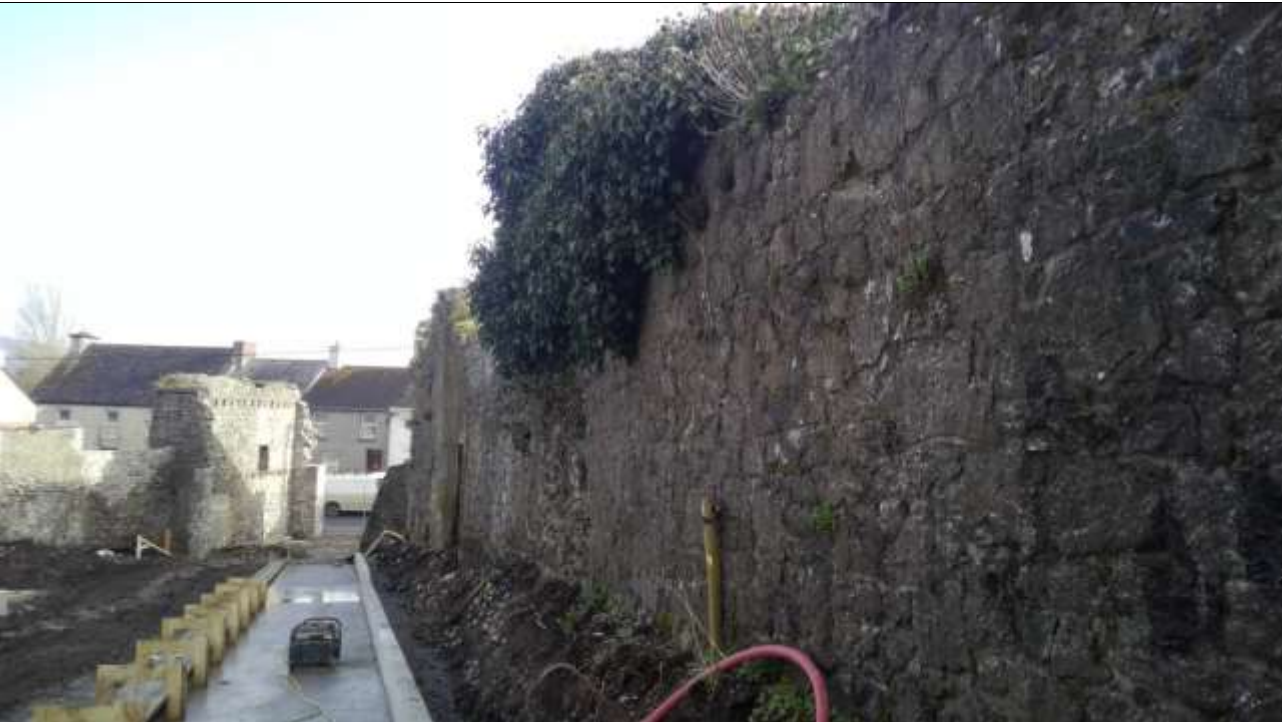
6. General view showing the presentation of the town wall within the new park. The upper part of the wall has been colonised by heavy ivy growth, which has broken down the haunch and threatens the stability of the wall.

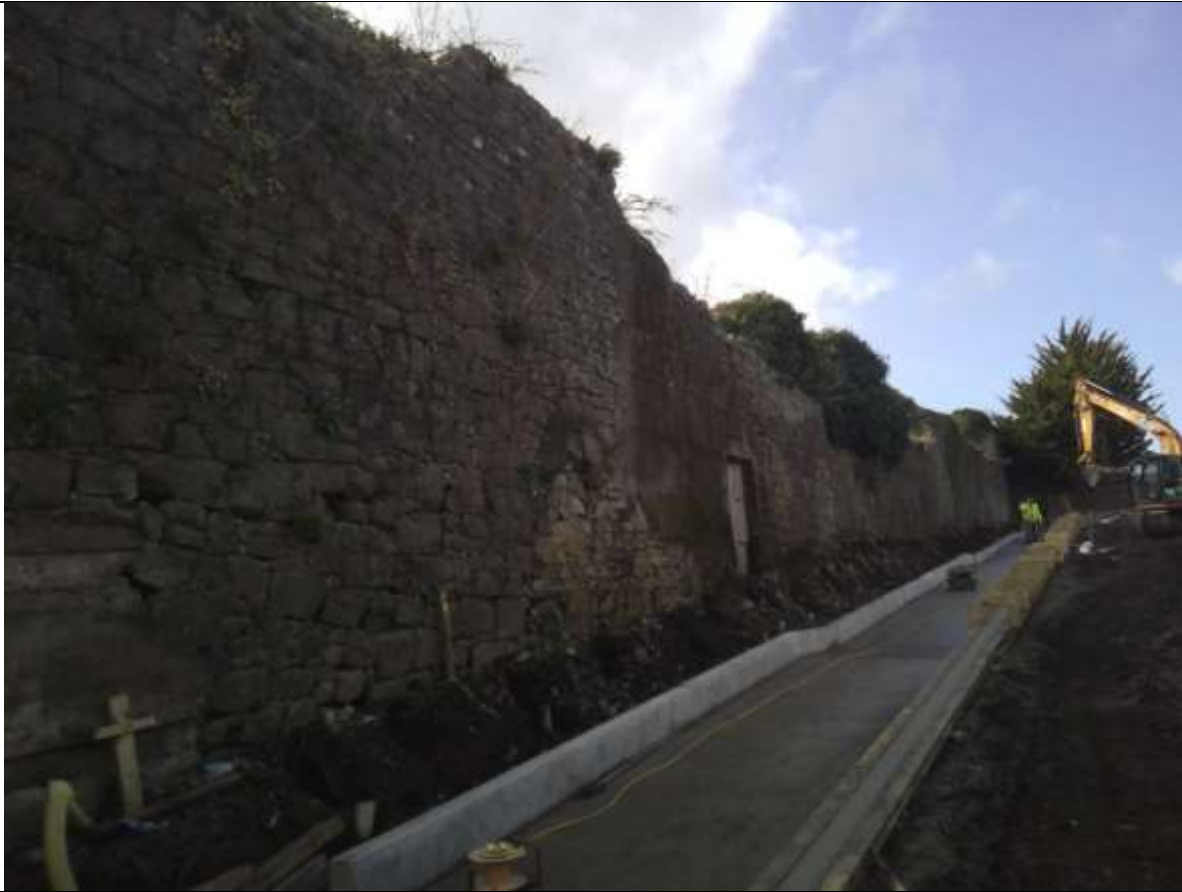
7. General view showing the presentation of the town wall within the new park (opposite direction to Pic. 6).

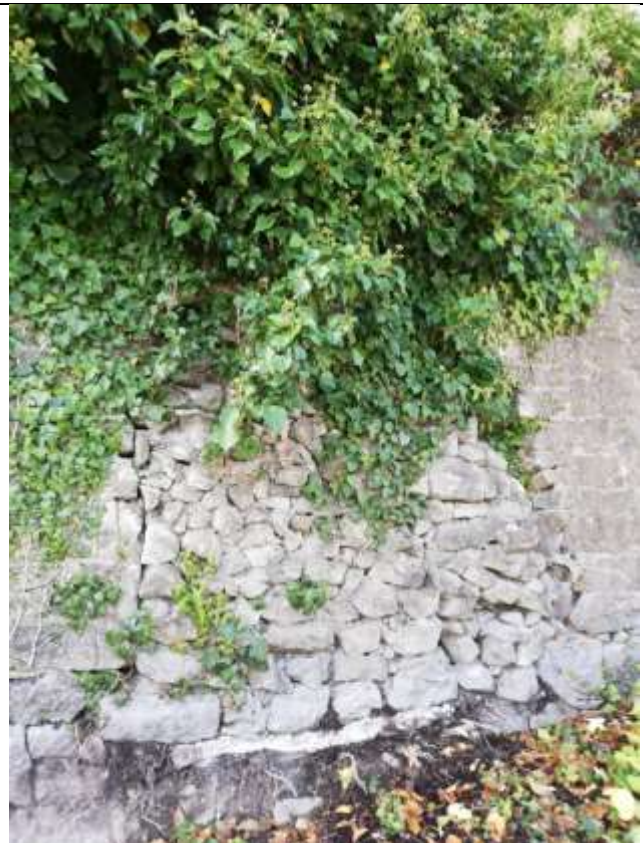
13. Earlier opening in wall, previously infilled with loose stone rubble. This photo was taken immediately prior to the works (in October 2019). Comparison with Photo 5 (above) shows how rapidly the ivy has grown in this location.
