CLONMEL TOWN WALLS

CONSERVATION AND MANAGEMENT PLAN

MARGARET QUINLAN ARCHITECTS
120 Rock Road Booterstown Co. Dublin

October 2009

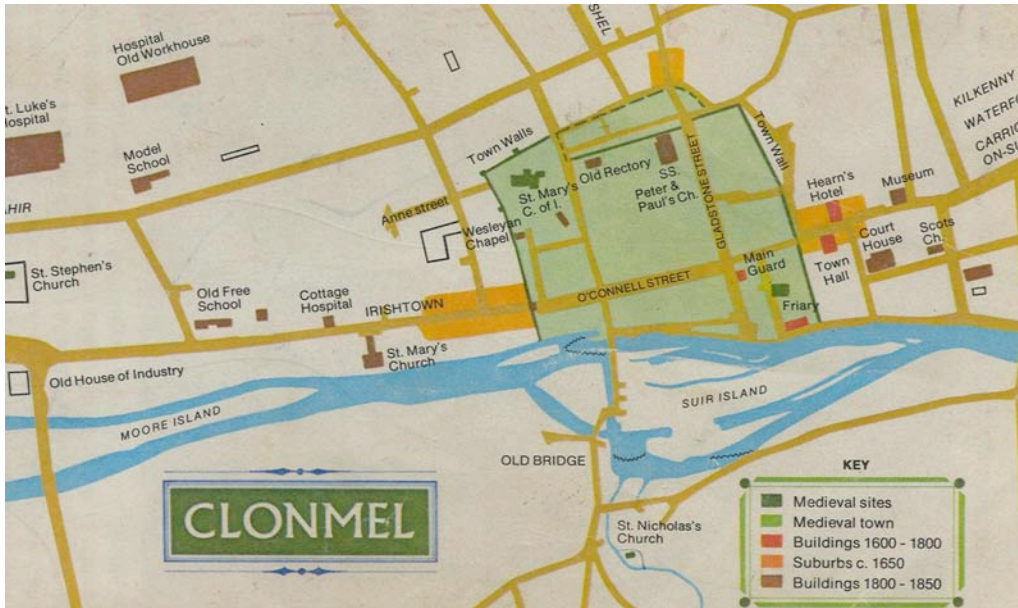
Shee and Watson map showing the line of the town walls, with the suggested line of the pre-1650 north wall shown dotted

In 1650 Cromwell laid siege to the town. The walls suffered heavy damage and all accounts concur that the north wall was breached. Shee and Watson suggest that the north wall may have been later rebuilt on a different line. The original wall may have continued in a straight line from east to west. Goubet's map shows the wall turning

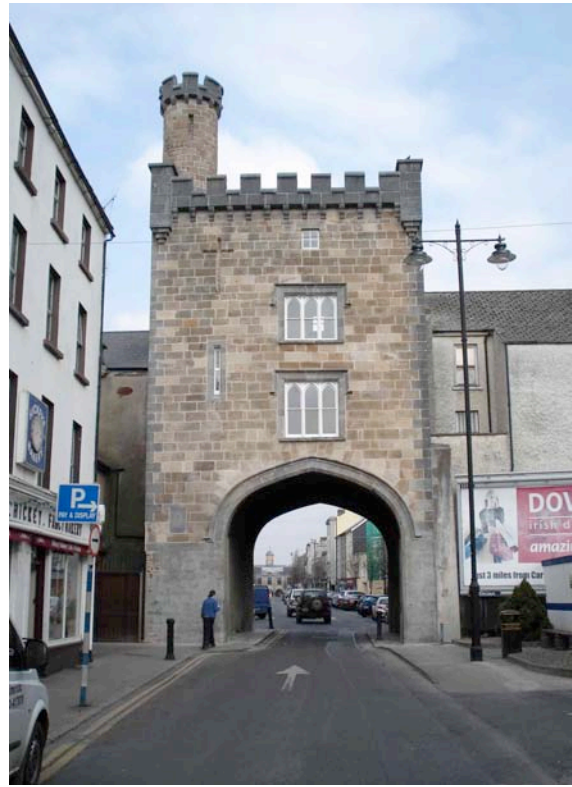
West gate from west

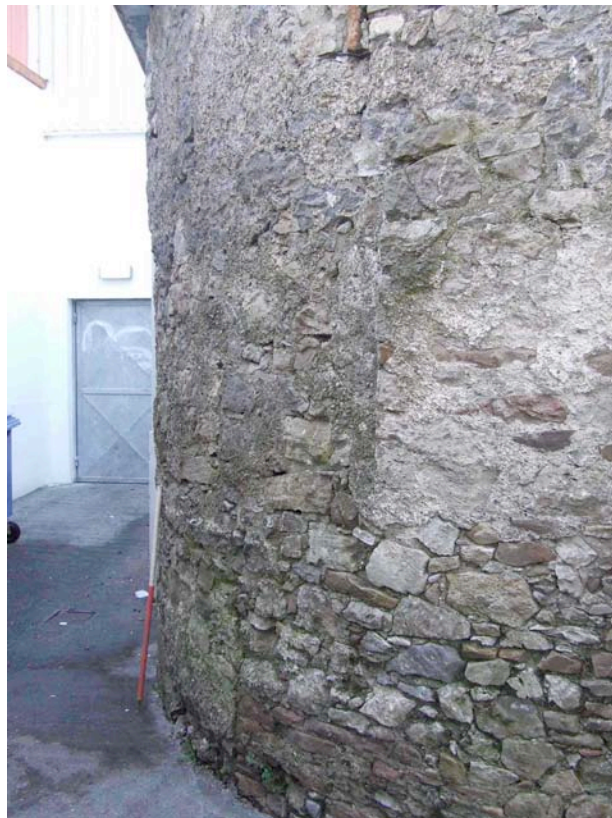
North-east corner turret incorporated into modern development

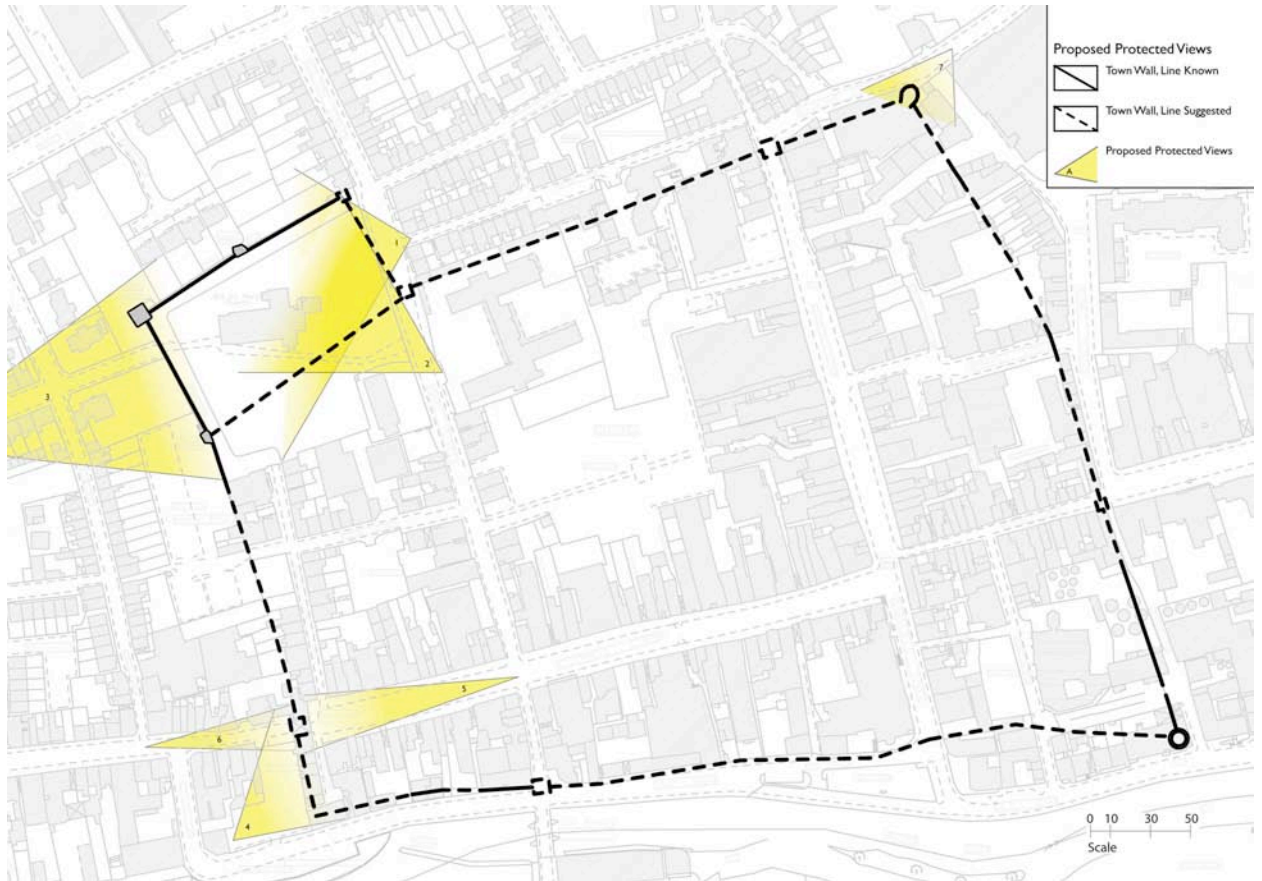
Proposed Protected Views Policy D1

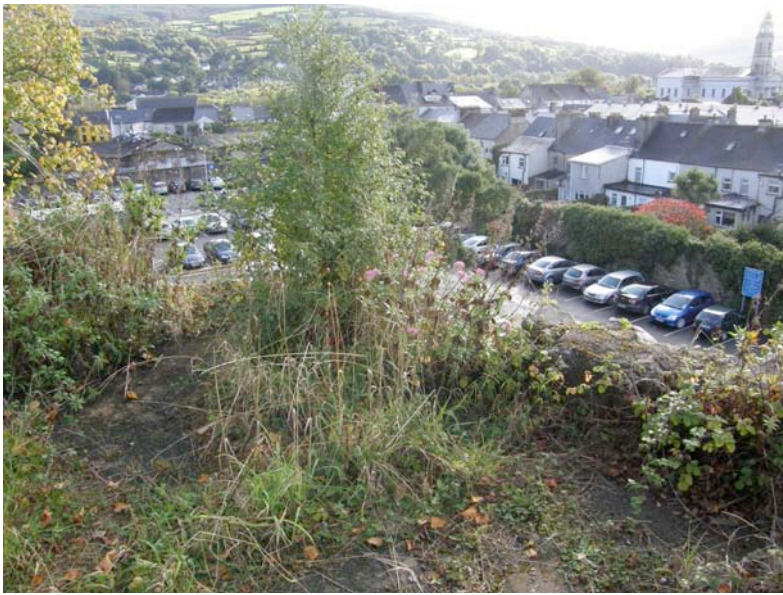
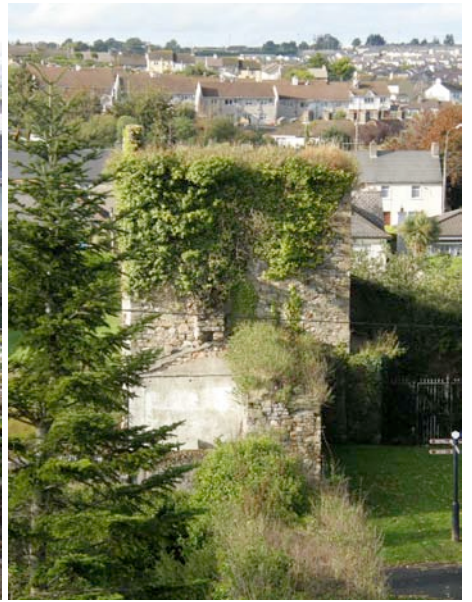
Views looking southwest and north from intermediate west tower, the proposed viewing point
Policy E1

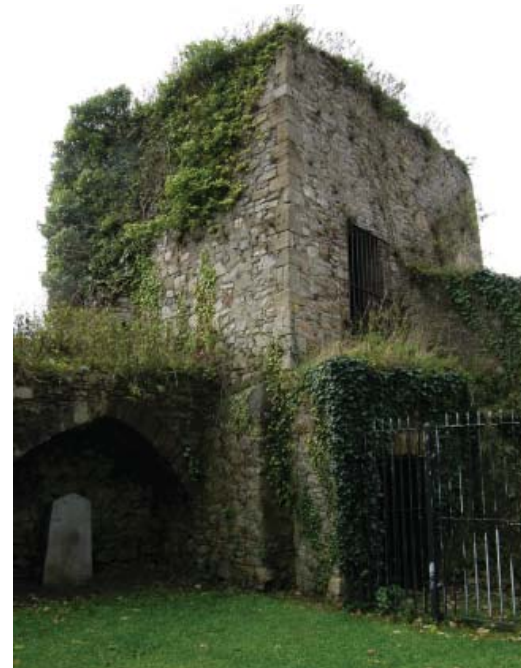
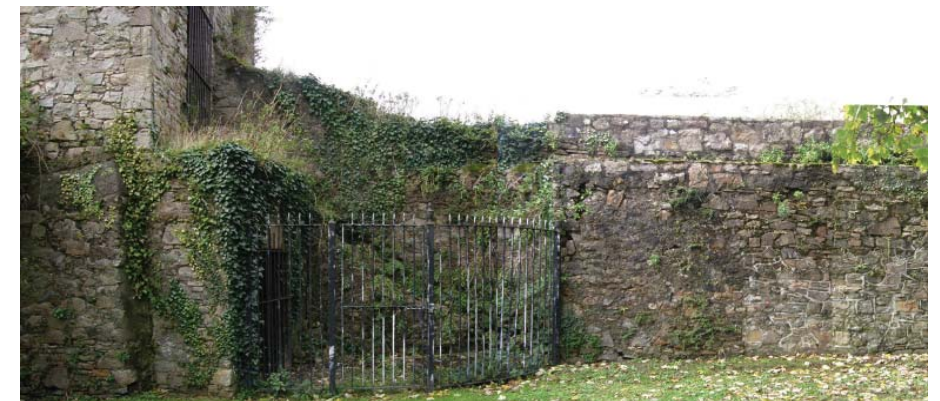
UPPER LEVEL PLAN 1:100

Old St Mary's churchyard to South.
Nos 3,4,5 Coolgreaney Close to North.
Length of solid wall from tower to vaulted section.
Burials within arches. Limestone string course over arch @ 50m and plaster to intrados.

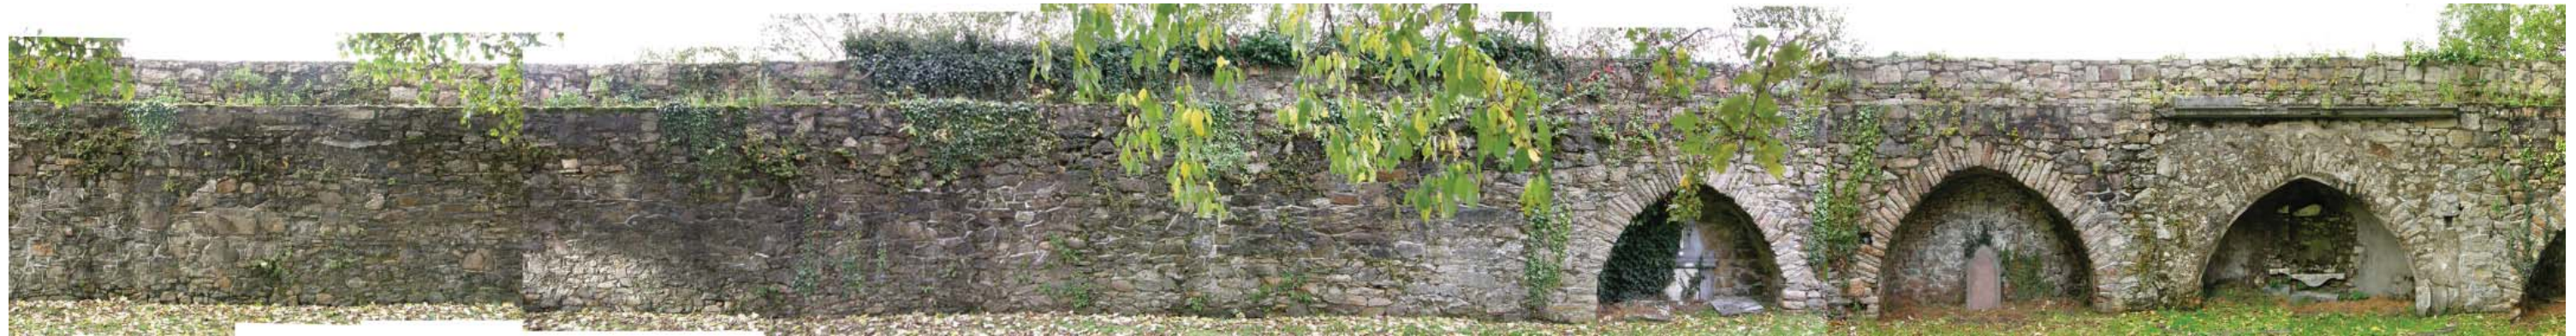
ELEVATION 1:100

Old St Mary's churchyard to South.
Nos 2 Coolgreaney Close and 1 Bolton Street to North.
Vaulted length of wall with tower accessed from ground
and from wall walk. Burials within arches.

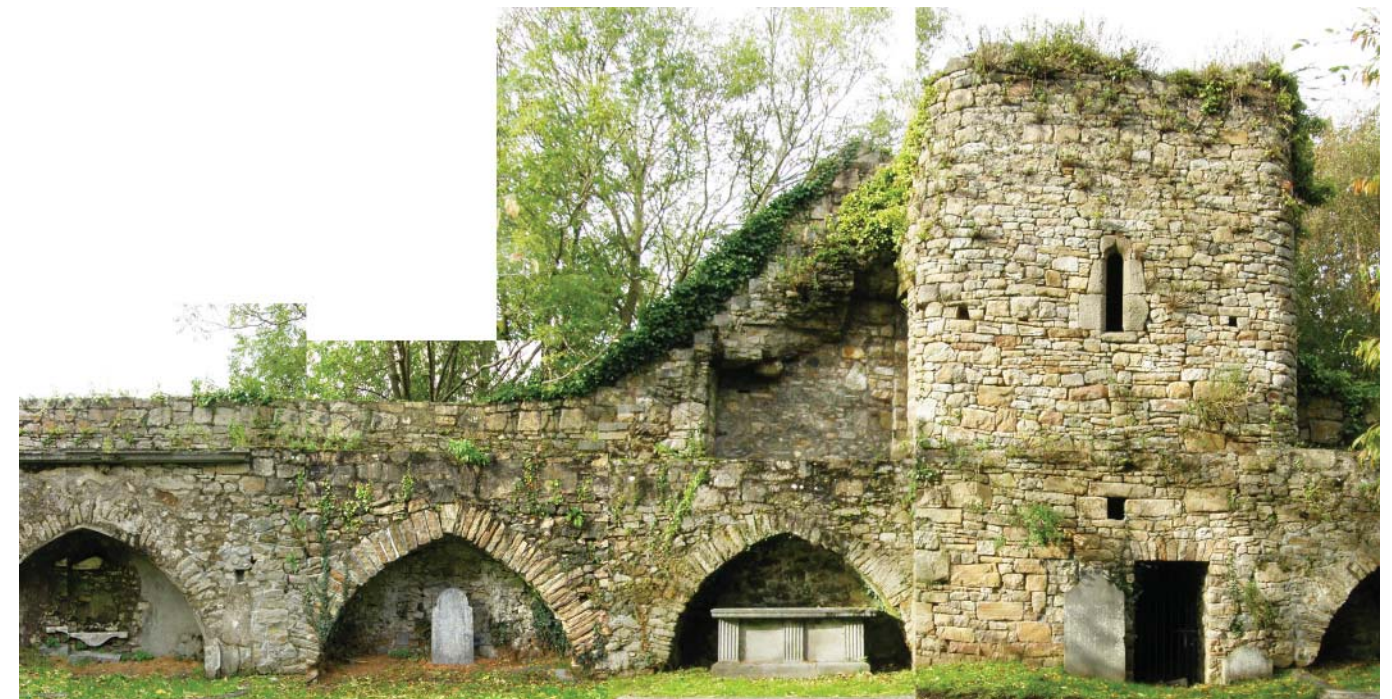
UPPER LEVEL PLAN 1:100

Old St Mary's churchyard to South.
No 1 Bolton St to North.
Length of vaulted wall. Burials within arches. One bay rendered with limestone pediment and box tomb to front @ 85m. Another with decorative render on intrados @ 100m.

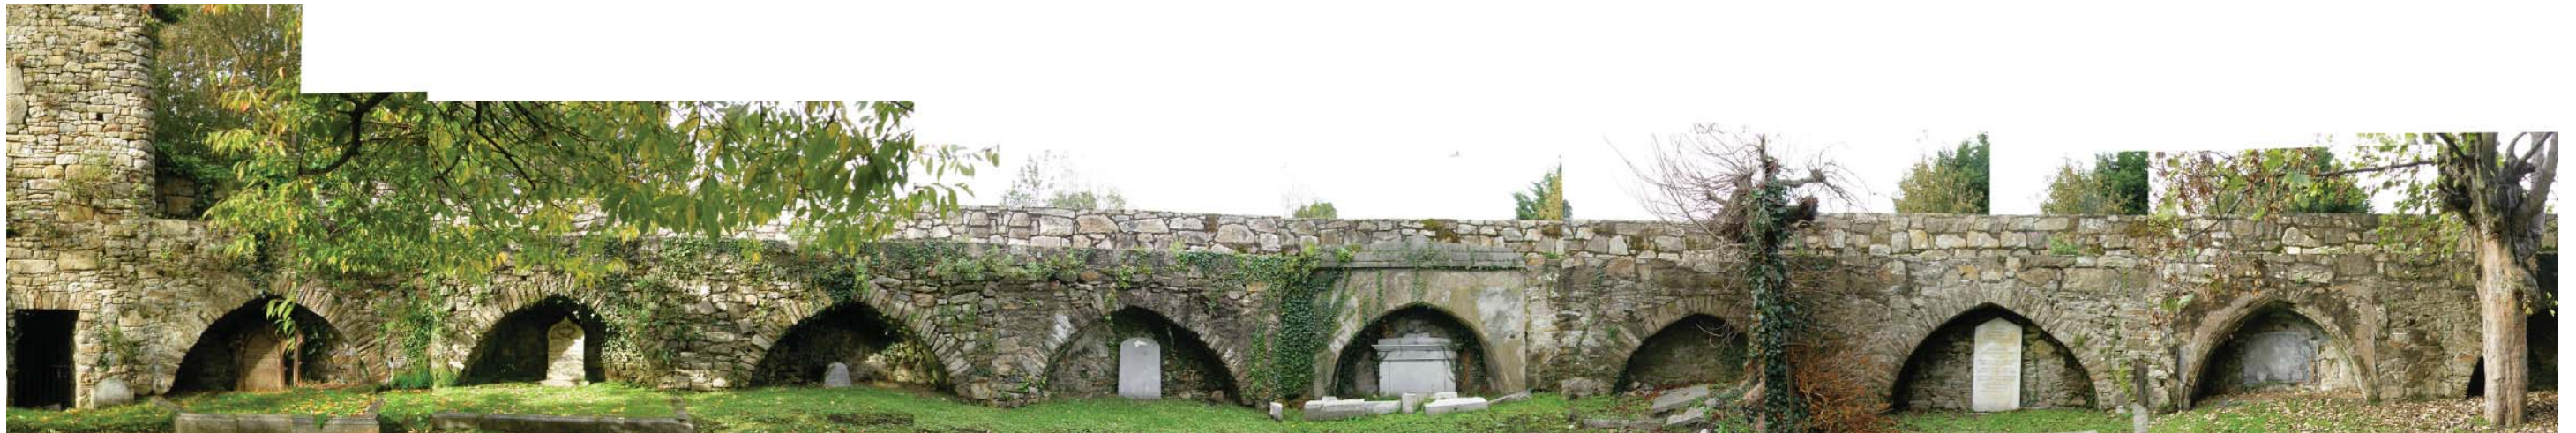
ELEVATION 1:100

Old St Mary's churchyard to South.
No 1 Bolton St to North.
Length of vaulted wall. End bay sheared off. Burials within arches. One bay rendered with pediment @ 113m. Trace of tower/bastion in adjoining garden. Wall rebuilt at Bolton St end at change of direction.

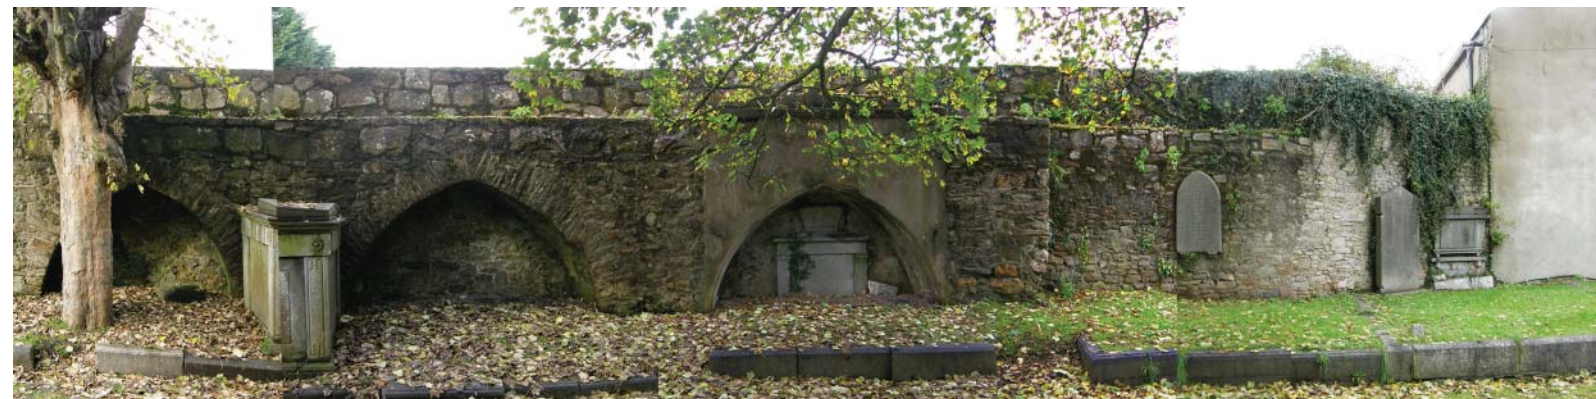
ELEVATION 1:100

Old St Mary's churchyard to East.
Montini, Queen Street to North and West.
Old St Mary's churchyard to East and South.
Length of vaulted wall from NW tower. Burials within
arches. Straight joints in wall @13m.

OTHER:
Some loose stone lying on ground.

PRIORITY:
Urgent: Cut back vegetation to assess condition. Treat and remove
vegetation. Repair masonry, including wall-tops. Point empty joints.
Medium-term: Any masonry repairs not deemed urgent
following assessment.

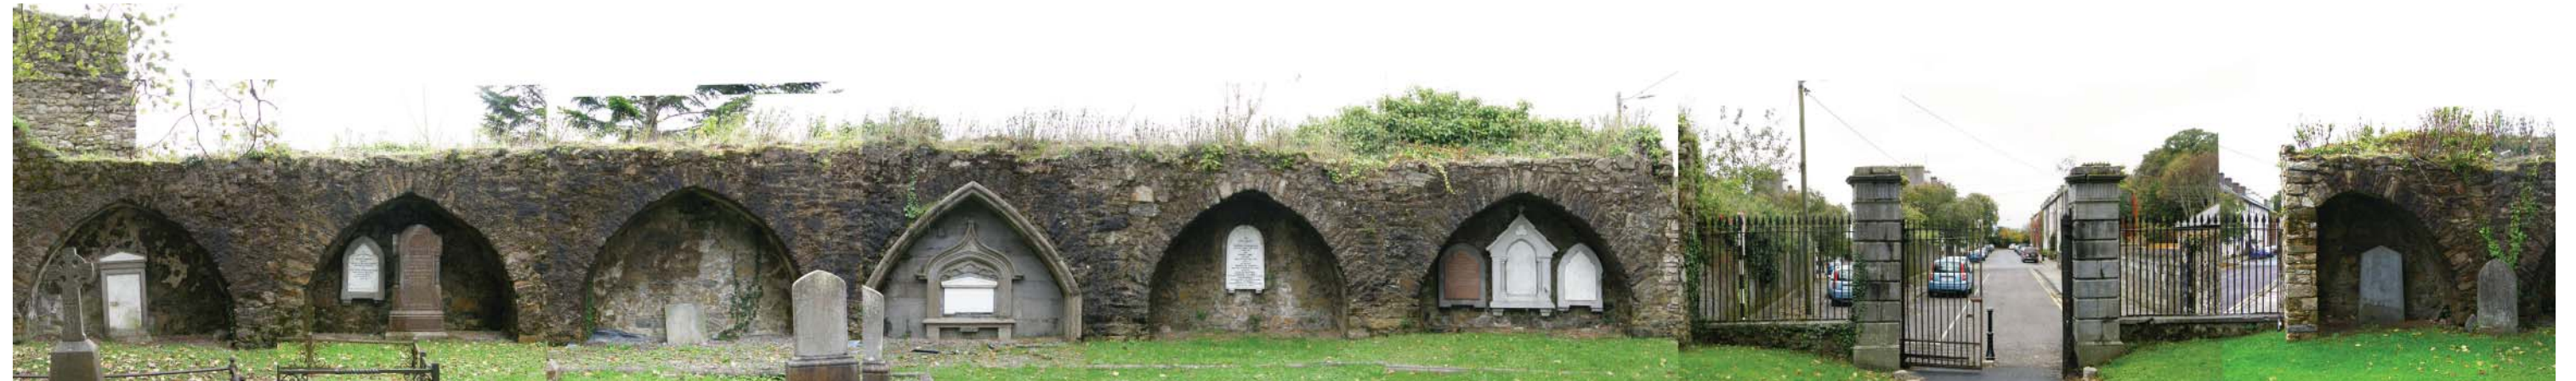
ELEVATION 1:100

Old St Mary's churchyard to East.
Myrtle Lodge and part Gordon Place car park to West.
Length of vaulted wall without parapet to 55m. Length
of higher wall with traces of original parapet height
from 55m with vaults sheared off. Traces of door/gate
ope @ 62m

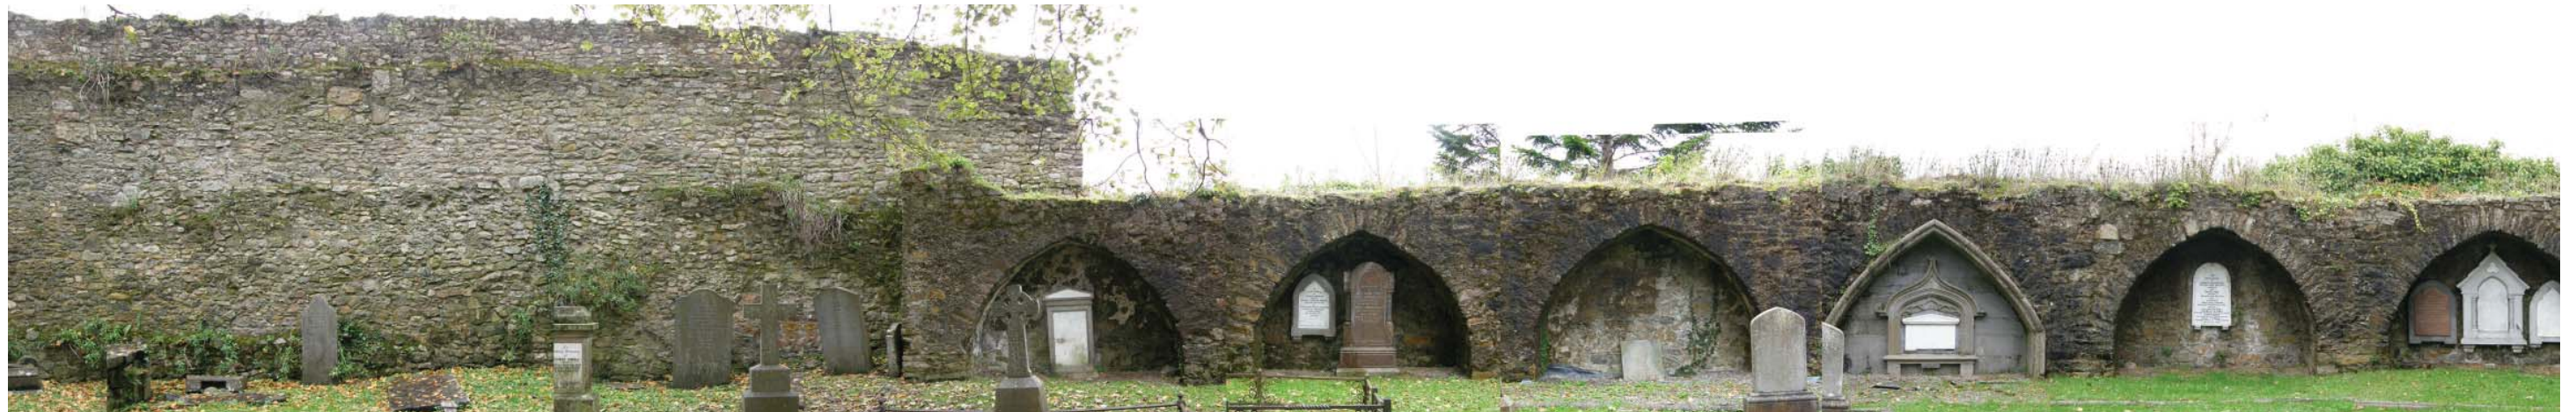
ELEVATION 1:100

Old St Mary's churchyard to East.
Gordon Place car park to West.
West intermediate tower and walls. Vault sheared off at
north corner of tower. Water stone survives.

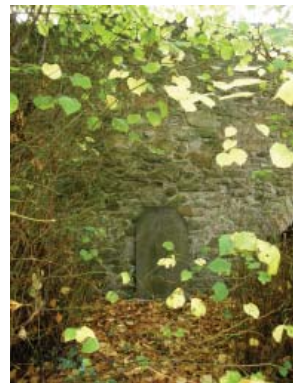
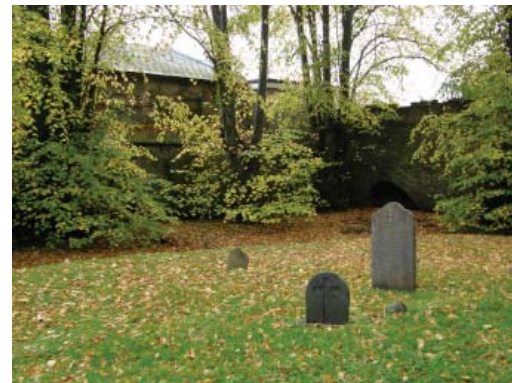
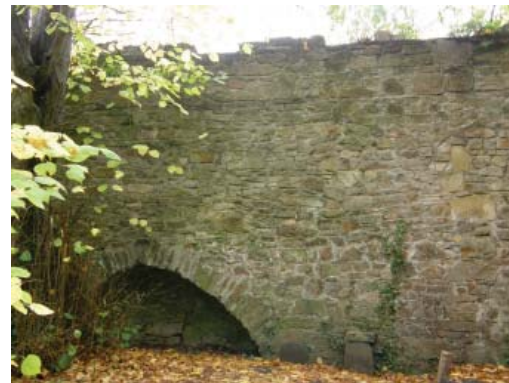
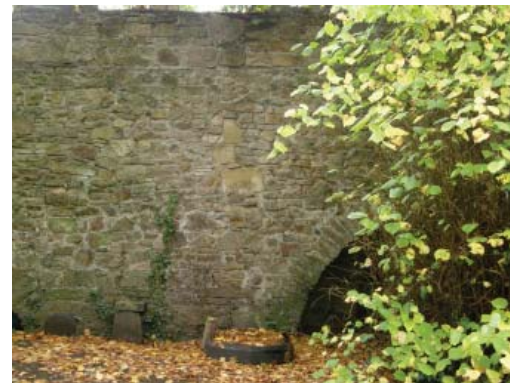
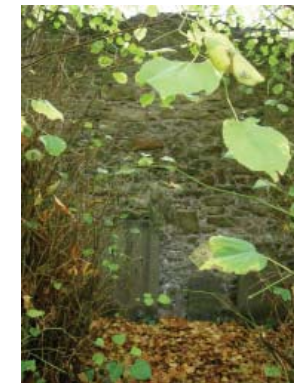
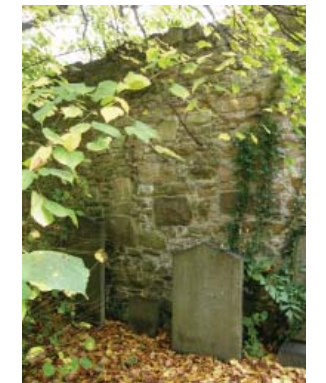
ELEVATION 1:100

Old St Mary's churchyard to South.
Montini, Queen Street to North.
There are lean to structures on the outer wall of the tower. This area was formerly stabling for draught horses for CIE. Loop at ground level

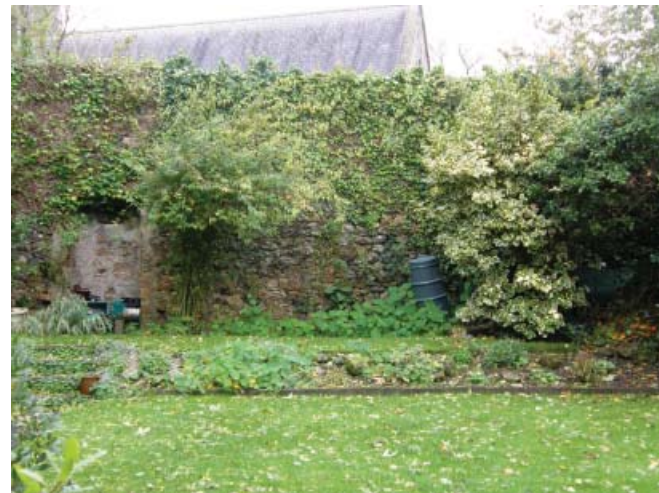
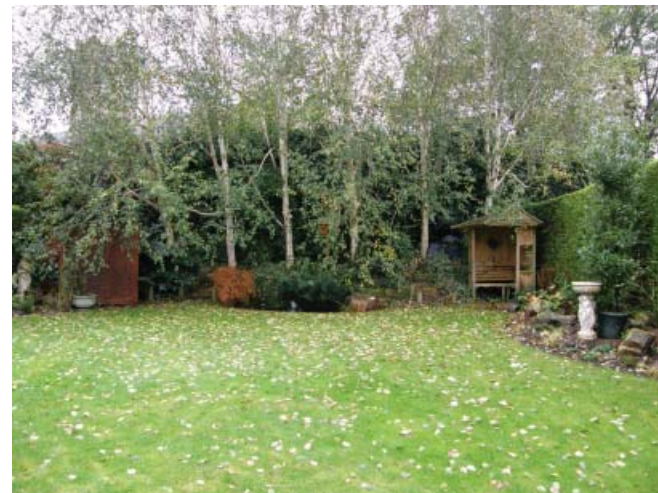
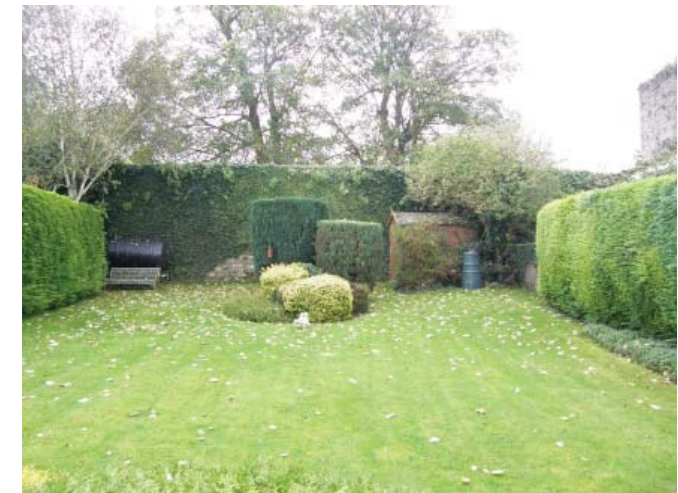
ELEVATION 1:100

Old St Mary's churchyard to South.
Nos 2 Coolgreaney Close to North.
North intermediate tower with wall. Upper part of wall may have been rebuilt mid 20thc.

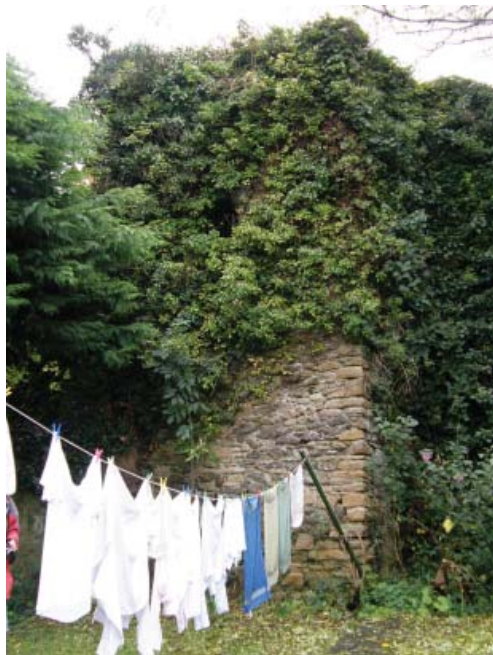
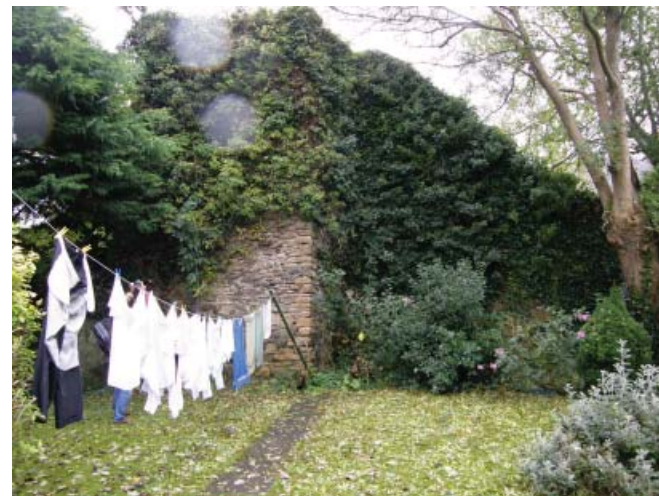
UPPER LEVEL PLAN 1:100

Old St Mary's churchyard to South.
No 1 Bolton St to North.
North of tower bounds No 1. Upper part of wall was
rebuilt mid 20thc.

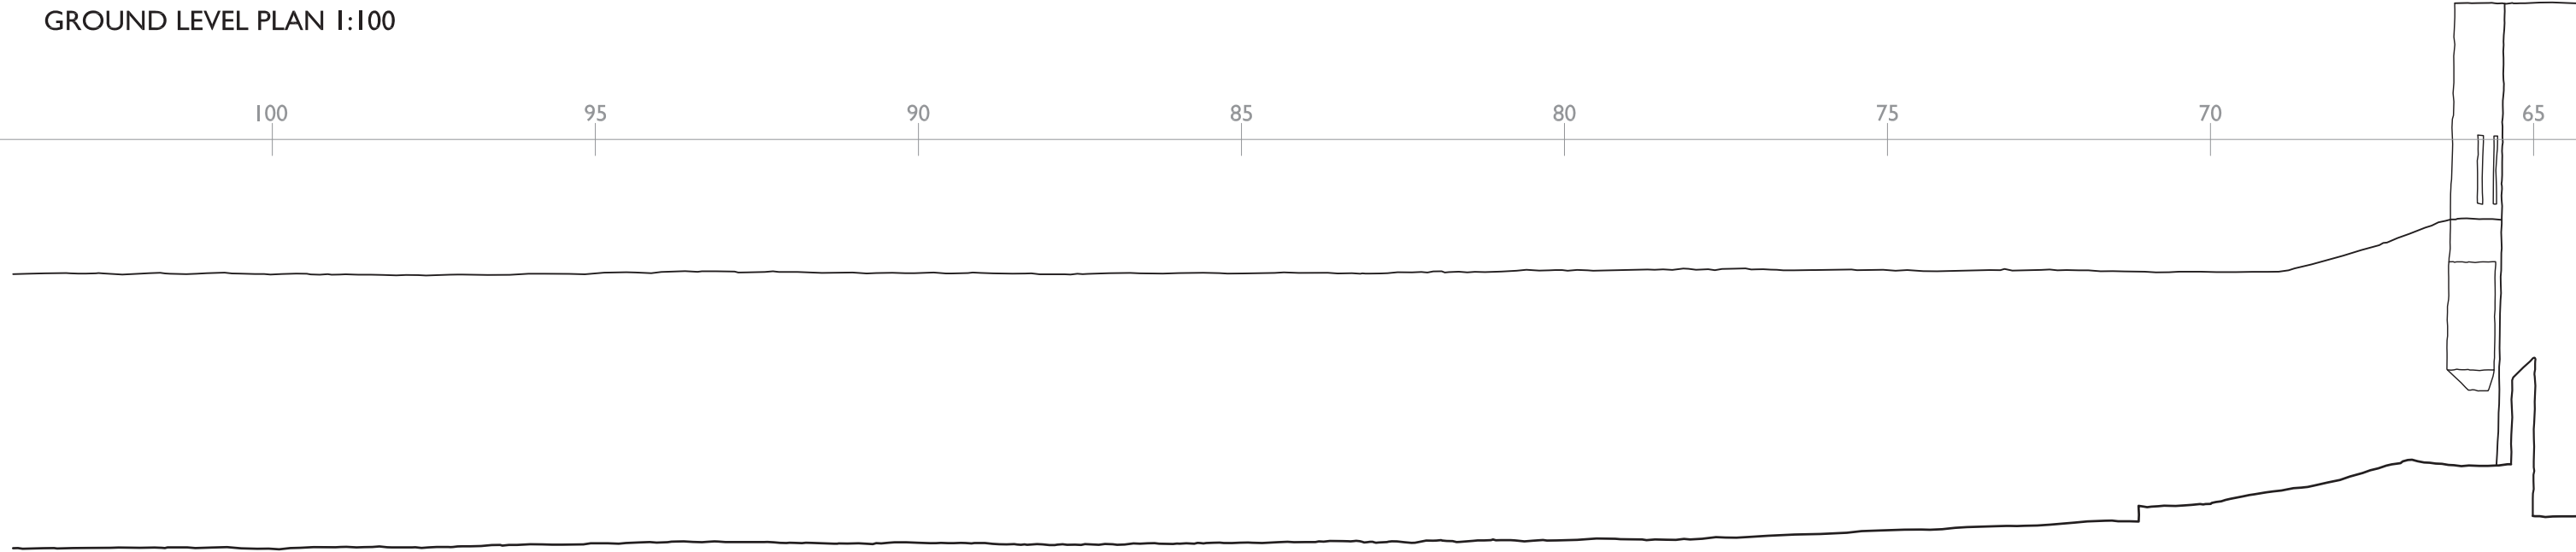
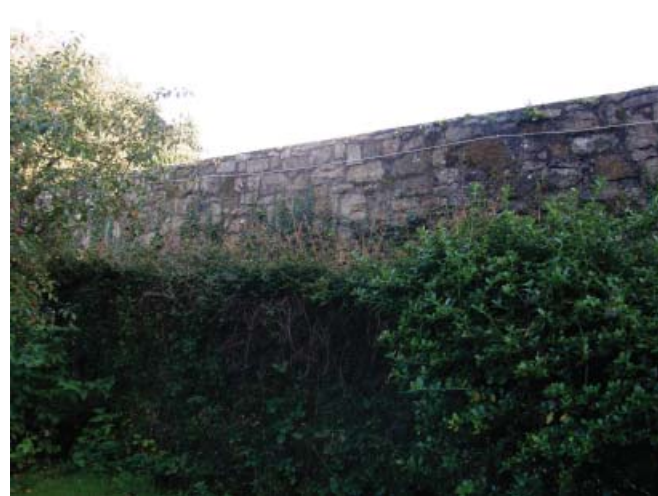
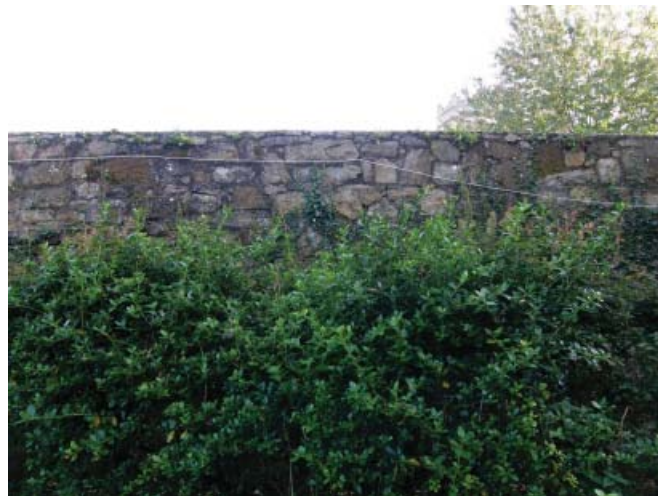
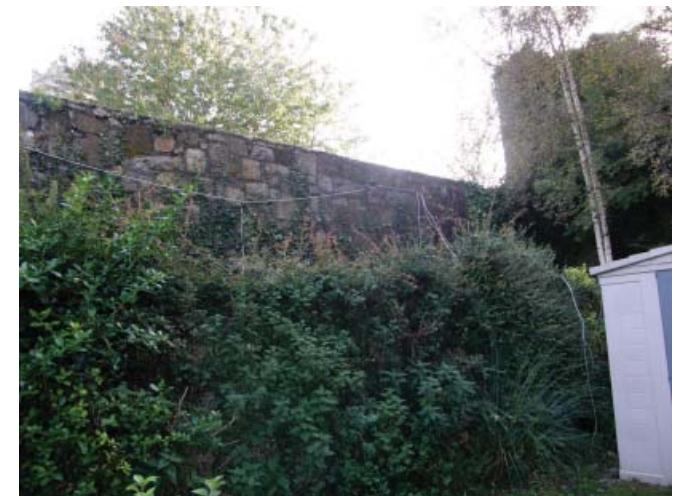
ELEVATION 1:100

Old St Mary's churchyard to South.
No 1 Bolton St to North.
North of tower bounds No 1. Upper part of wall was
rebuilt mid 20thc. Trace of probable tower/bastion with
batter adjoining house. Lean-tos against wall.

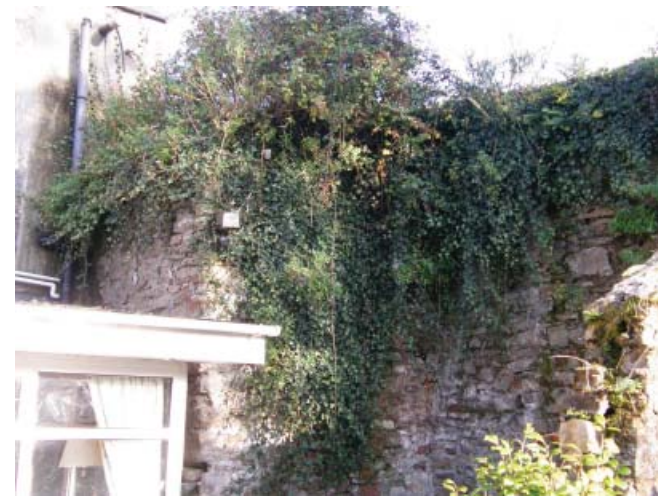
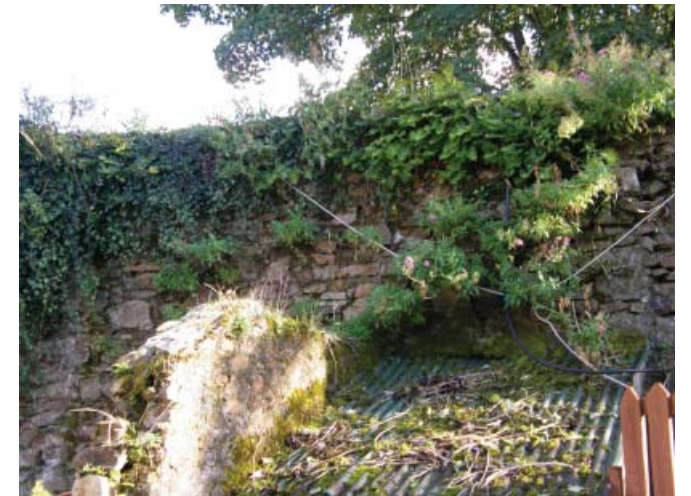
ELEVATION 1:100

Old St Mary's churchyard to East.
Montini, Queen Street to North and West.
This area was formerly stabling for draught horses for CIE. Old St Mary's churchyard to east and south. Length of vaulted wall from NW tower. Burials within arches. Straight joints in wall @ 13m.

OTHER:
Straight joints from gate/door in wall.

PRIORITY:
As North Section I.
Urgent: Clip back ivy to assess condition. Treat, remove + repair masonry, including wall-tops and openings.
Medium-term: Removal of plaster from demolished lean-to.

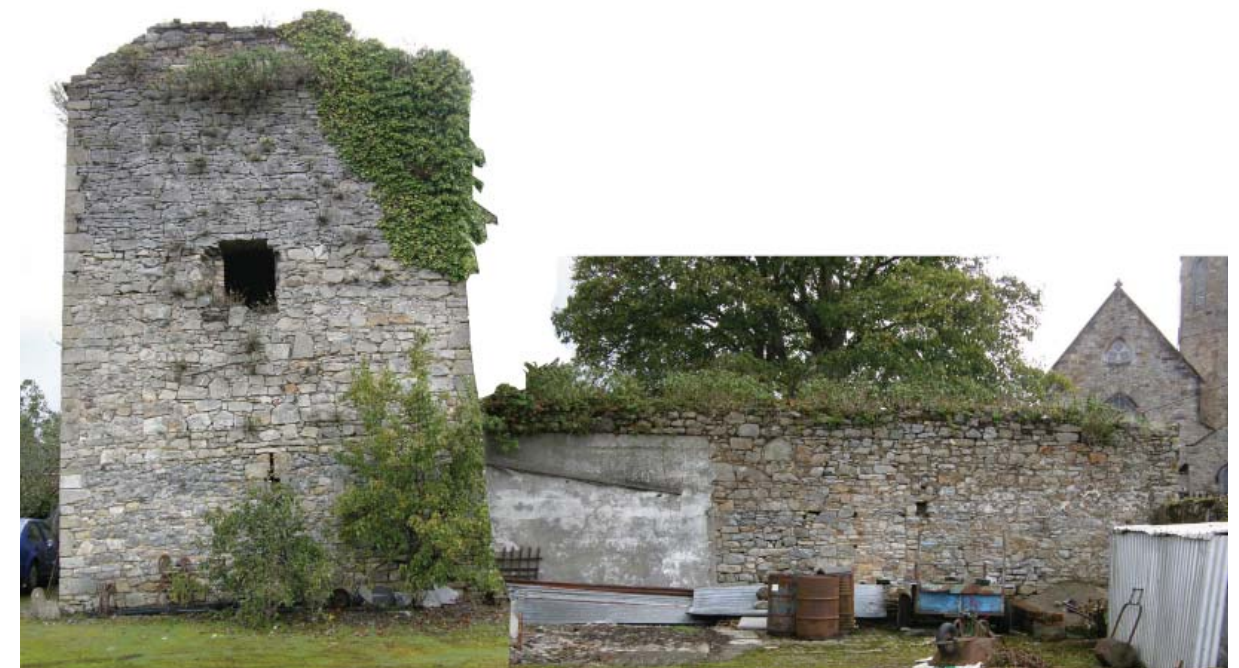
ELEVATION 1:100

DESCRIPTION: See Text Section 2.3
See Gazetteer Section 7 Interior

Old St Mary's churchyard to East.
Anne Street and Myrtle Lodge to West.
19th c entrance @ 18m – 28m with limestone piers
and railings.

CONDITION:

Assessment in Myrtle Lodge not possible
because of vegetation. Repairs likely to be
required. Missing stones noted.

Liaise with owners for access for repair; treatment and
removal of vegetation. Assess the condition of masonry
when vegetation is removed and repair as necessary.
Rebed capstone on north gate-pier.

Urgent: Treat and remove vegetation. Repair
masonry, including wall-tops. Point where necessary.
Medium-term: Any masonry repairs not deemed
urgent following assessment.

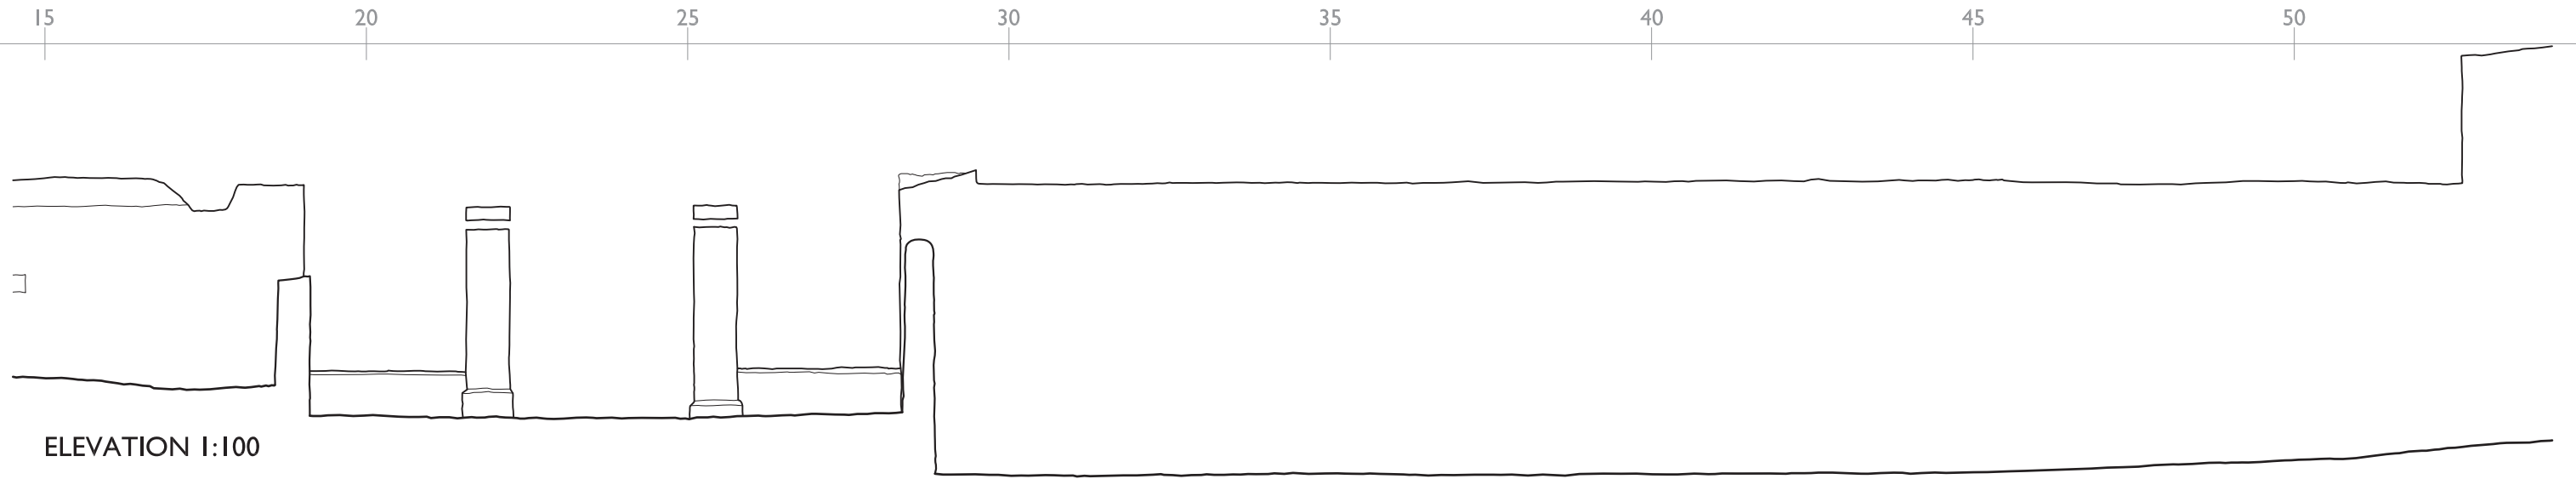
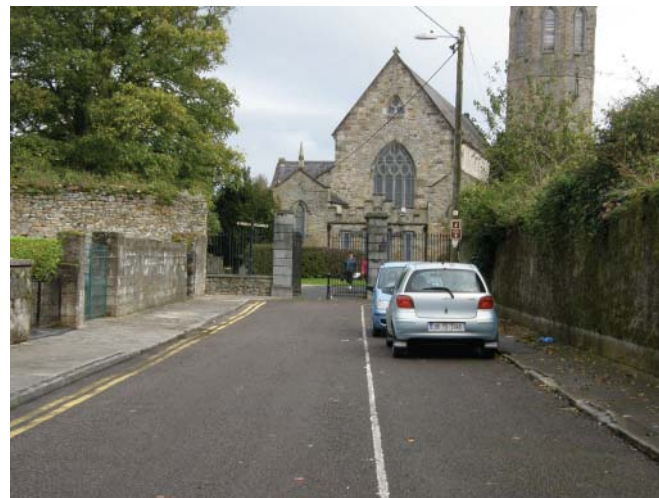
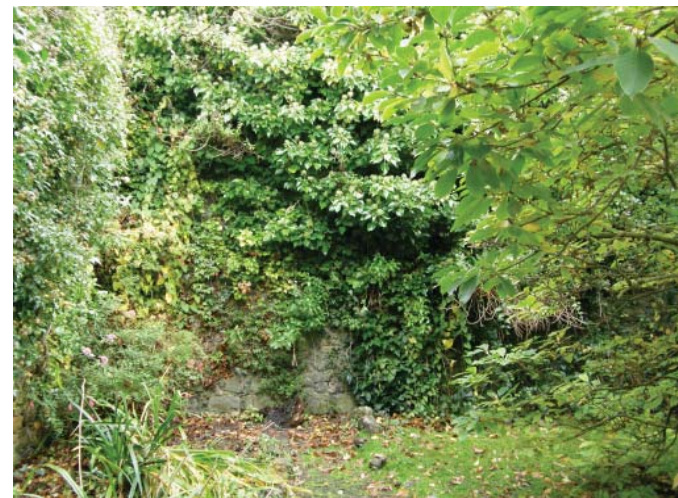
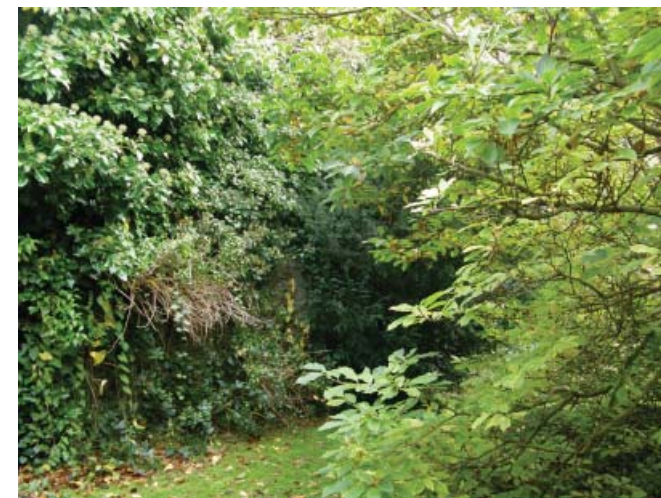
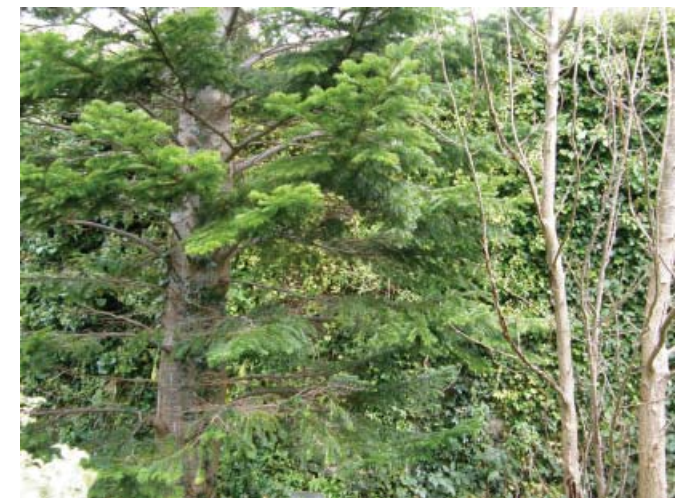
GROUND LEVEL PLAN 1:100

DESCRIPTION: See Text Section 2.3
See Gazeteer Section 8 Interior

Old St Mary's churchyard to East.
Gordon Place car park to West.
Flight of steps supported by 3 no arched recesses to west
intermediate tower adapted to 19thc garden folly. Trace of
gate/door ope in wall now blocked.

CONDITION:

The wall is in reasonable condition.
Vegetation is becoming reestablished
in places. Flight of steps in very poor
condition.

Treatment and removal of vegetation. Assess the condition of
masonry when vegetation is removed and repair as necessary.
Repair flight of steps by rebedding and replacing missing stone.
Extent of repair depends on decision re access.

Urgent: Treat and remove vegetation. Replace missing
stone. Repair mortar where necessary. Repair stair.
Medium-term: Any masonry repairs not deemed
urgent following assessment.

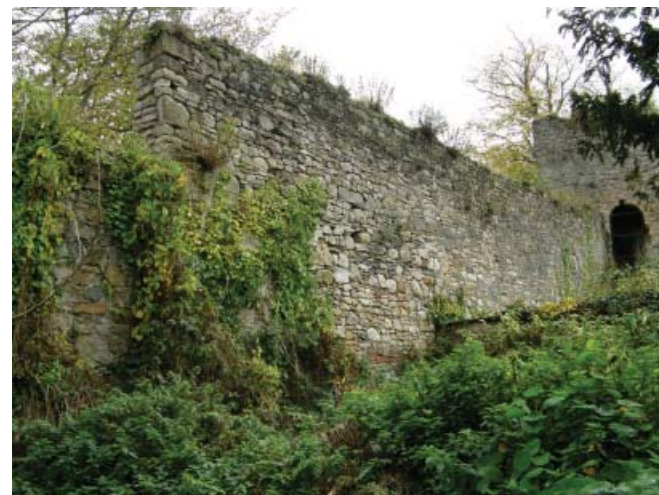
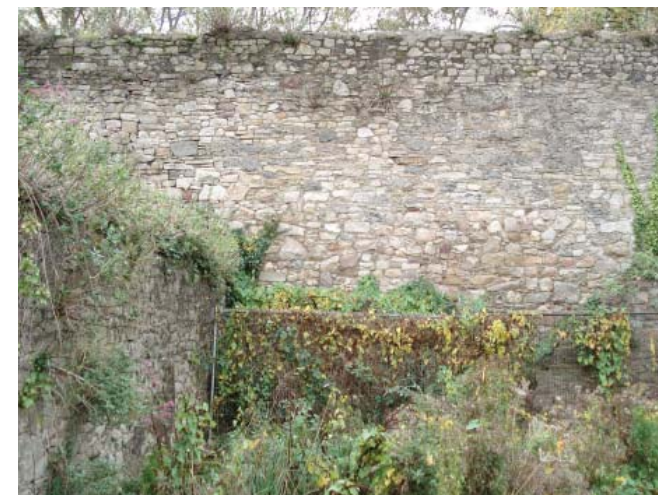
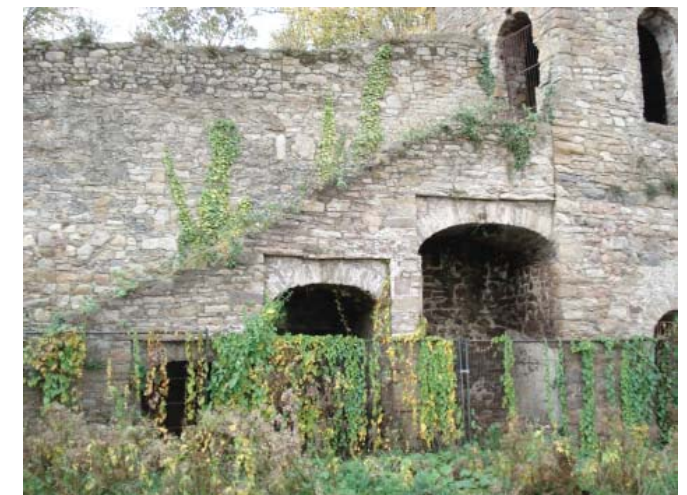
DESCRIPTION: See Text Section 2.3
See Gazetteer Section 9 Interior

Old St Mary's churchyard to East.
Gordon Place car park to West.
West intermediate tower and walls. Outer faces of tower
and interior altered in 19c to adapt to garden folly.
Round-headed opes inserted. Water stone survives.

CONDITION:
The wall is in fairly good condition. Repair/
repointing carried out within the last 10
years. Vegetation is becoming reestablished
in places. Wall tops of tower have some
loose masonry.

ACTION:
Treatment and removal of vegetation. Repair as necessary.
Clear roof of growth and replace mortar. Flaunch wall tops.
Other actions depend on decision re access.

PRIORITY:
Urgent: Treat and remove vegetation. Repair mortar
where necessary. Flaunch wall tops.
Medium-term: Any masonry repairs not deemed
urgent following assessment.

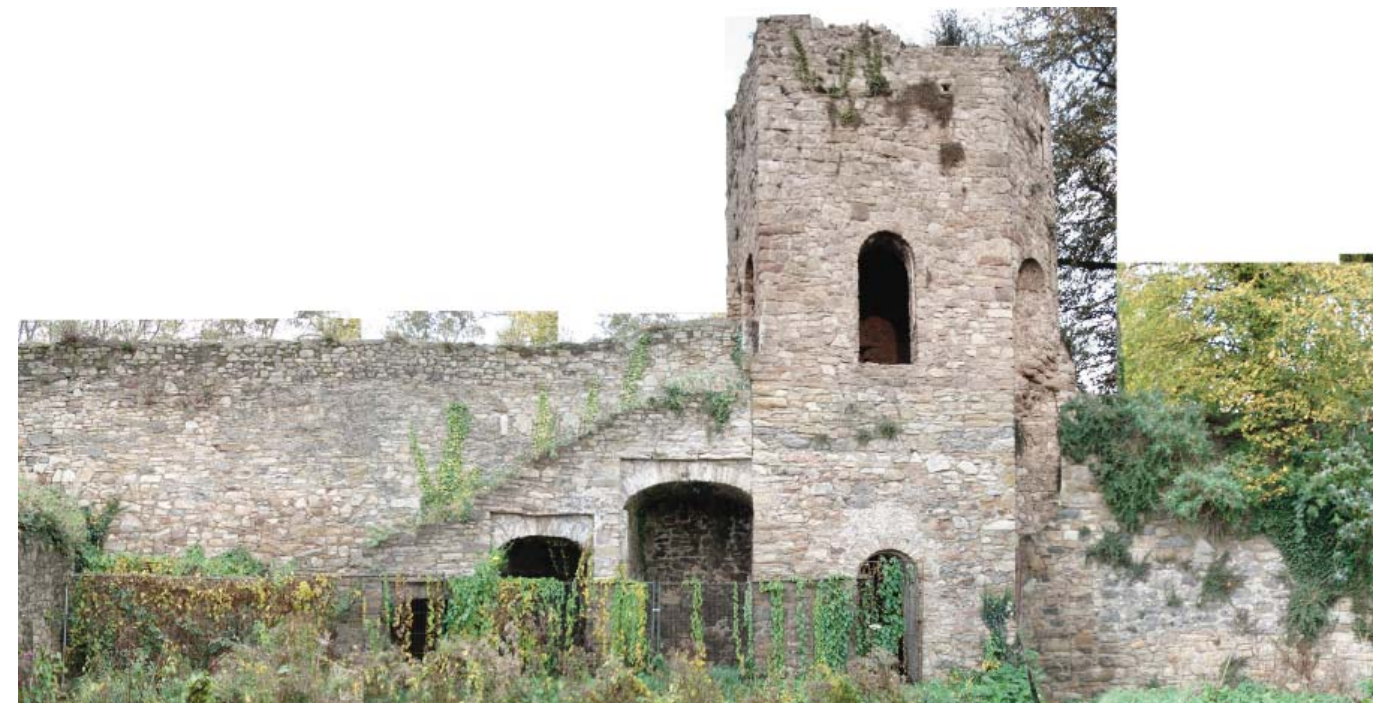
UPPER LEVEL PLAN 1:100

DESCRIPTION: See Text Section 2.3
See Gazetteer Section 10 Interior

Old St Mary's churchyard to East.
Gordon Place car park to West.
Length of wall without parapet from tower to its southern limit at rear
of Peter Street properties @ c. 113m. This section represents the early
wall circuit turning east immediately before the tower. The wall has
been raised and there appears to be a ledge on the outside.

CONDITION:

The wall is in reasonable condition but
there is a lot of vegetation rooted on the
ledge.

Treatment and removal of vegetation. Assess the
condition of masonry when vegetation is removed
and repair as necessary.

Urgent: Treat and remove vegetation. Repair
mortar where necessary. Flaunch wall-top and
ledge.

Medium-term: Any masonry repairs not
deemed urgent following assessment.
