Comhairle Contae Thiobraid Árann  
Tipperary County Council

## Suir Island Masterplan – Appendices

**Appropriate Assessment Screening  
For the development of Suir Island, Clonmel,  
Co. Tipperary**

**- Suir Island Masterplan -**

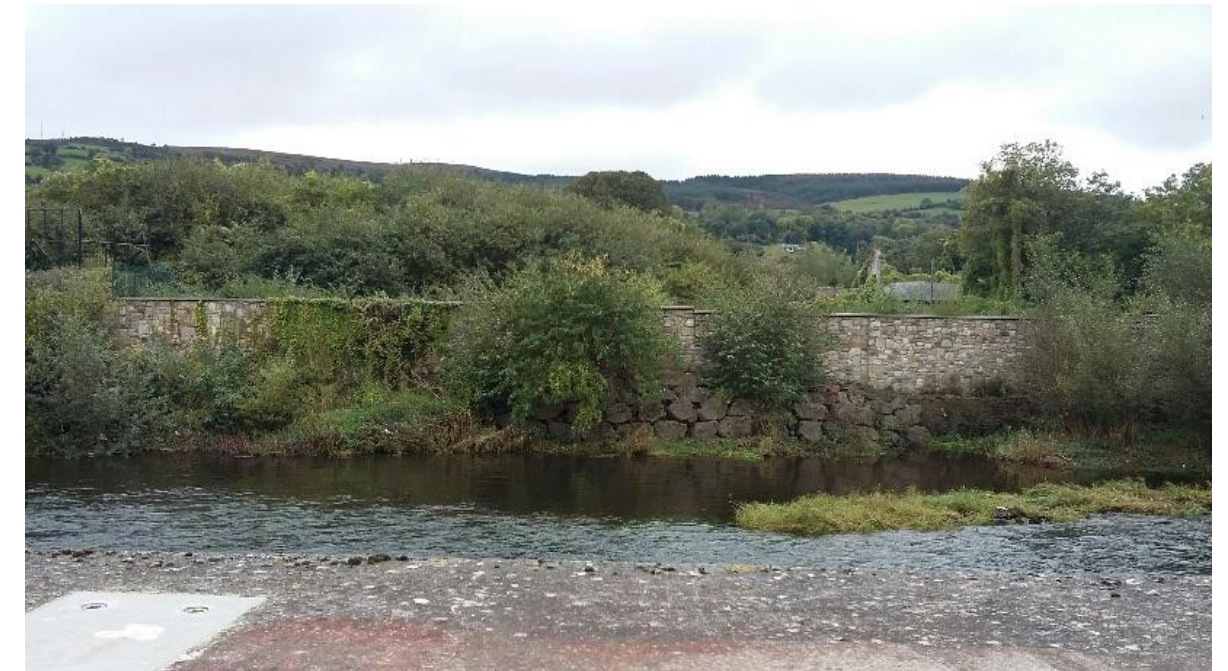
**Figure 1.**  
Below highlights a suitable area for the footbridge. There would be no impact on the trees.

The arboricultural impact on the above is not known at this stage until final design is agreed. However from discussions with the architects woodland paths and two pedestrian bridges are the main source of development. The pathways through the island will be constructed with compacted earth and or loose gravel either method will involve little if any excavations works thus reducing the soil compaction and or root severance. Where the path meets tree root greater than 200mm it is proposed to continue the path by means of a boardwalk which will involve no excavation therefore no root disturbance.

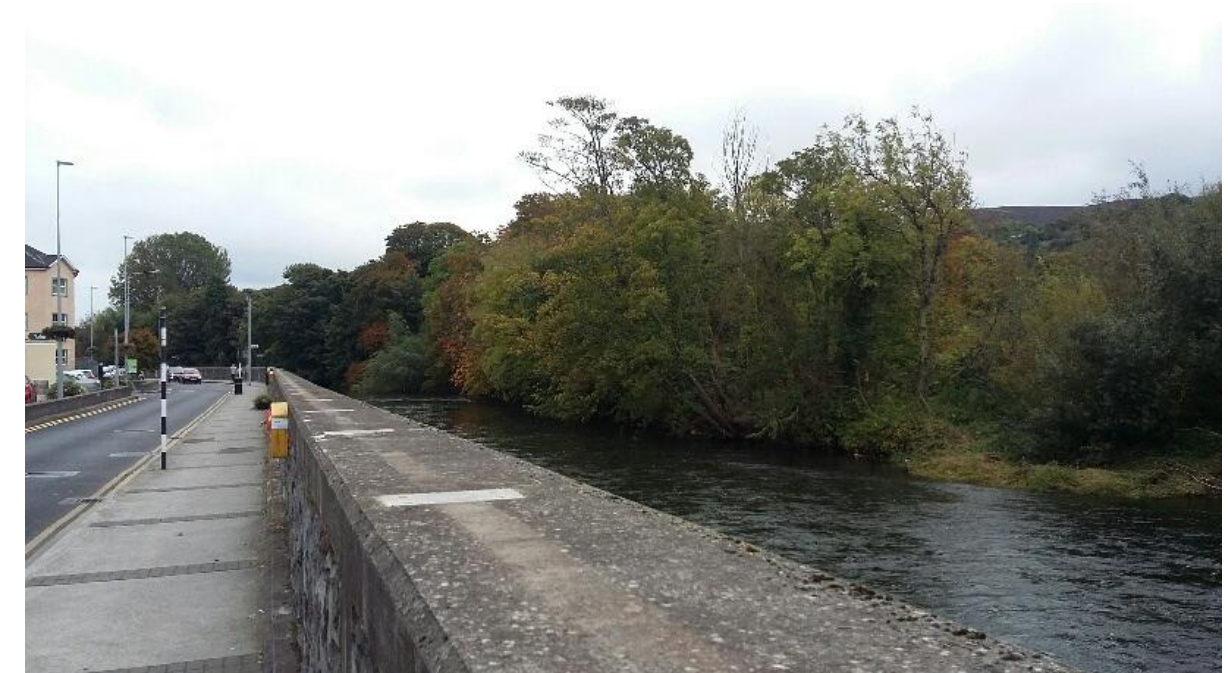
**Figure 2.** Displays the trees along the spit. Due to their location they could not be safely tagged. However they are of high amenity value and in good condition

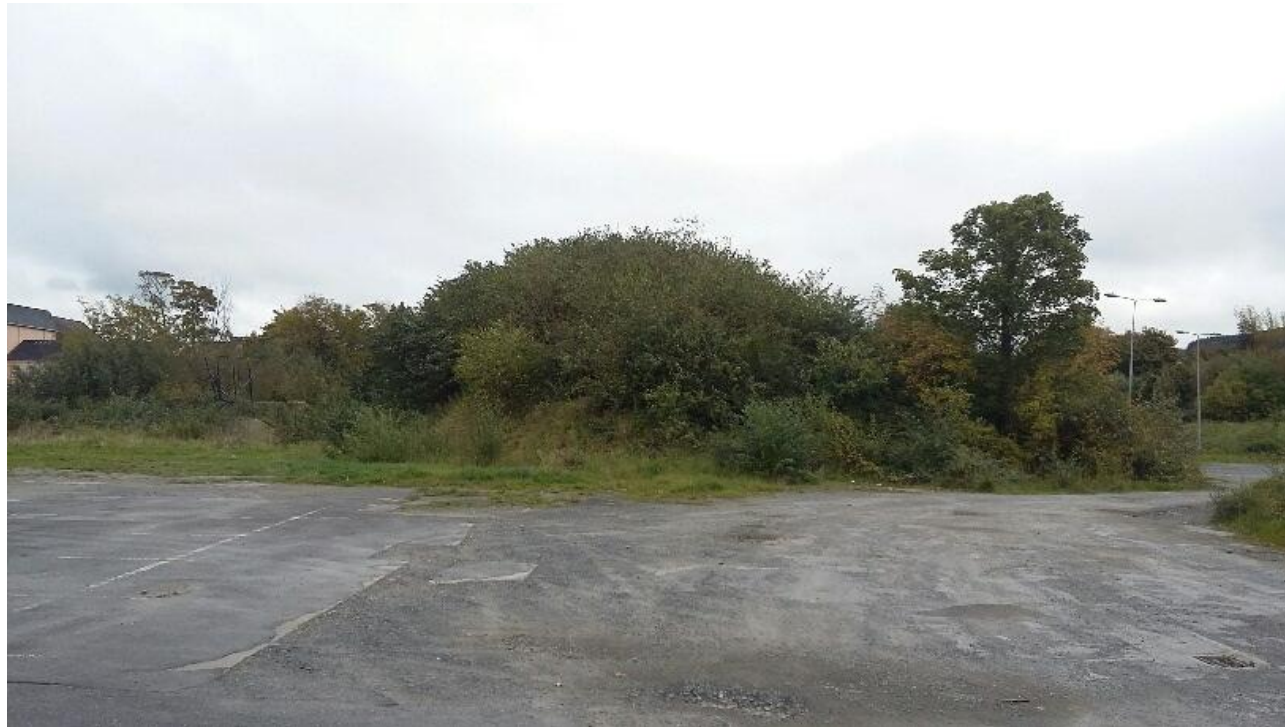
**Figure 3. Displays the soil heap that is over grown.**

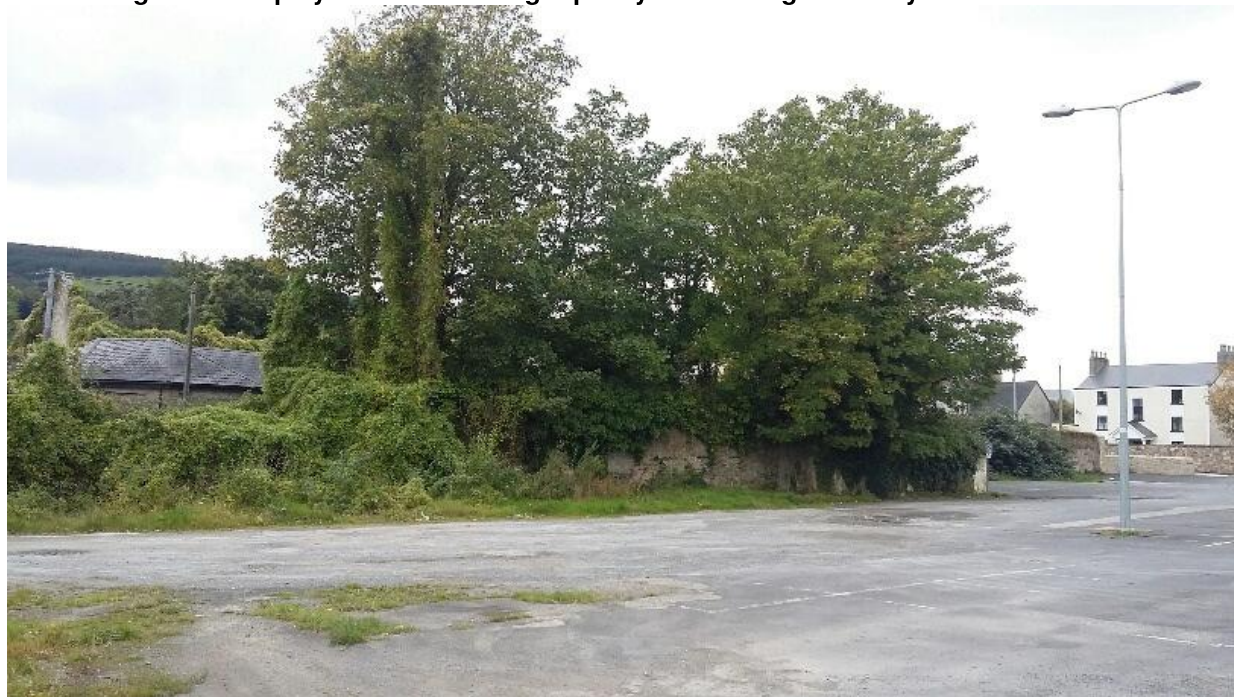
**Figure 4. Displays trees 2201. High quality trees of high amenity value**

Tree # <sup>1</sup>	Species	Age class	Size <sup>2</sup> (mm)	Height (M)	Crown Sp.(M)	Crown Cl.(M)	Condition <sup>3</sup>	Structural/Physiological Observations	Remedial Recommendation	Category <sup>4</sup>	RPA <sup>6</sup> Radius m
T2201 x 3	<i>Acer pseudoplatanus</i> Sycamore	M	500	16	N=4 S=4 E=4 W=4	2	Good	Represents three mature sycamores located within the old mill. High amenity value due to their location	Retain- no works required	B2	6m
T2202	<i>Tilia x europea</i> Common Lime	OM	1200	26	N=7 S=7 E=7 W=7	4	Good	A large OM lime displaying a good overall condition. A fantastic specimen of high amenity value	Retain- no works required	A2	12m
T2203	<i>Taxus baccata</i> 'Fastigiata' Irish Yew	SM	250	6	N=2 S=2 E=2 W=2	1	Good	A semi-mature Yew displaying a good overall condition.	Retain- no works required	C2	3.5m
T2204	<i>Quercus ilex</i> Holm Oak	OM	1000	14	N=5 S=5 E=6 W=6	1	Fair	An overmature Oak, displaying a fair overall condition it has suffered basal damage in the past, however recent tree surgery works have lessened the risk of failure occurring.	Retain –no works required	C2	12m

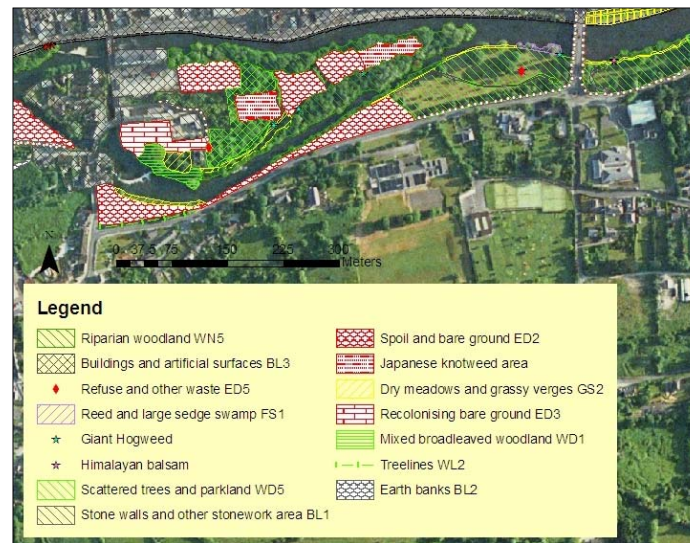
Figure. 4.1. Digitised image of habitat boundaries and other features of ecological interest recorded within Sites No 042004 (Denis Burke Park) and 042007 (Suir Island)

All habitats and features of ecological interest recorded within Denis Burke Park (Site No 042004) and Suir Island (Site No 042007) and are presented in Fig. 4.1.

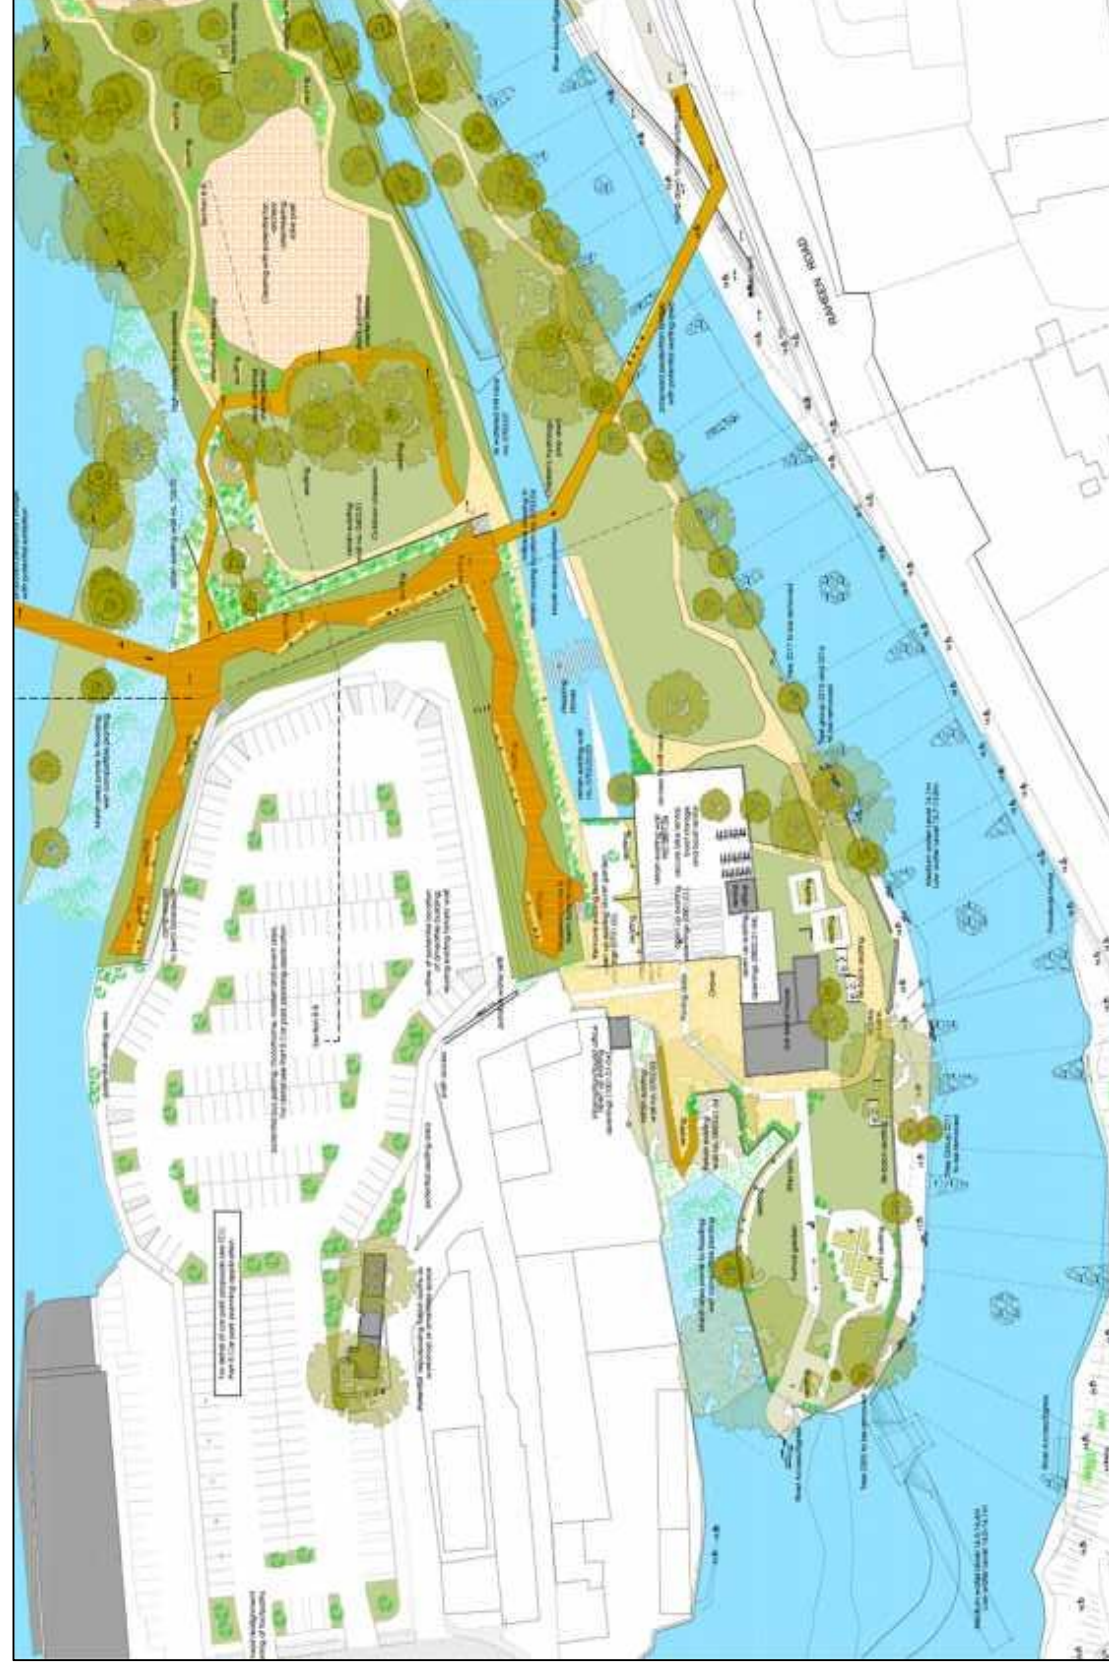
Figure 2.2 – Site Layout Plan (Western and Central Extent - Kenneth Hennessy architects)

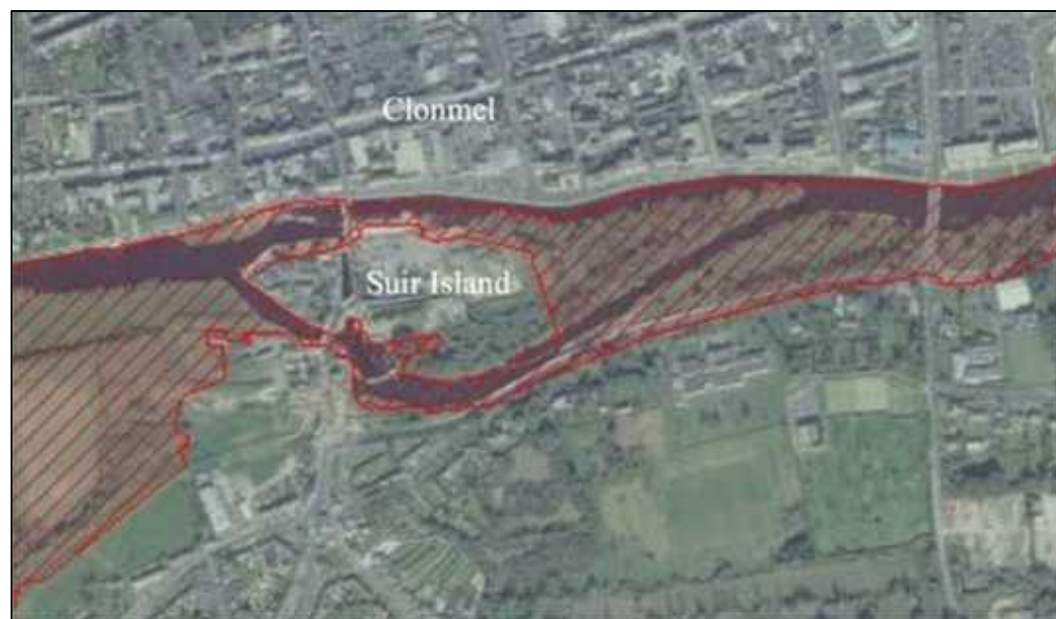
**Figure 4.2** - Section of Lower River Suir SAC adjacent to Clonmel © National Parks & Wildlife Service, OSI, and esri Ireland (SAC boundary illustrated in red hatching)

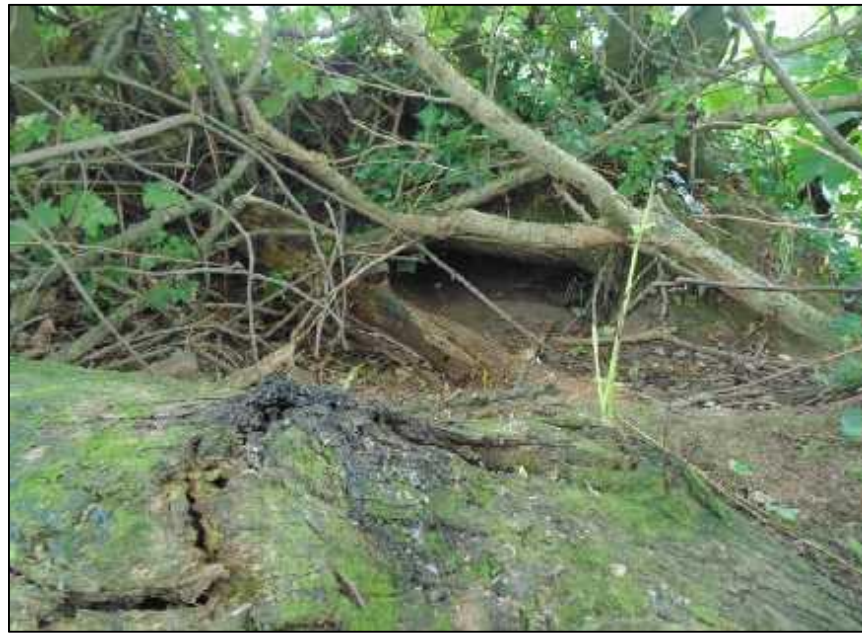
**Plate 6.1** – Otter holt at Suir Island (eastern point of island)

While otters can successfully live in urban areas (Sleeman and Moore, 2005) and can tolerate a degree of disturbance (Bassett and Wynn, 2010) they favour secluded areas away from human disturbance for breeding and resting (pers. obs.). At Suir Island, a potential breeding holt was detected at the eastern point of the island. This area was very overgrown with scrub and difficult to access with no evidence of any recent access by people. There were abundant signs of otter activity in this area including a holt with two visible entrances and accompanied spraint areas on adjoining willow bark and worn trails with roll areas. Any activity encroaching on this area of the island may impact breeding otter and given that the local otter populations form part of the SAC population. Therefore, impacts could be considered significant if the population at Suir Island was disturbed. Indeed, there are proposals to create a boardwalk and path into the undisturbed areas of the eastern extent of the island according to the development masterplan. Such encroachment in an area, where it is very important to provide seclusion for otter undisturbed from human activity, could impact the otter population. Other indirect impacts, could be considered associated with water quality impacts given the proposed radical changes to the wider footprint of Suir Island (i.e. pedestrian bridges, wildwood clearings, facilities building and boardwalk). The effects of such wide level construction activities remain unknown and could also indirectly impact the local prey resources outside of direct disturbance.

Indirect effects (i.e. reduction in prey availability because of turbid water/ pollution etc.), may be greater in light of the decimation of the white-clawed crayfish population because of crayfish plague. This could mean that fish prey and other sources of food are now a greater part of the otter population's energy budget. While the phased nature of the Suir Island masterplan development will help reduce impacts to otter (i.e. constructed in stages rather than all at once), any disturbances near breeding areas could result in otter no longer breeding at Suir Island.
